## PROPERTY REPORT

**Property Name:** 50 South Main Street  
**Address:** 50 S MAIN ST

PS&S recommends that 50 S. Main Street, which includes a Colonial Revival-style residence and garage constructed circa 1910-1920, is a contributing property in the Cranbury Historic District.

**Survey Name:** Cranbury Local Historic District Survey 2018

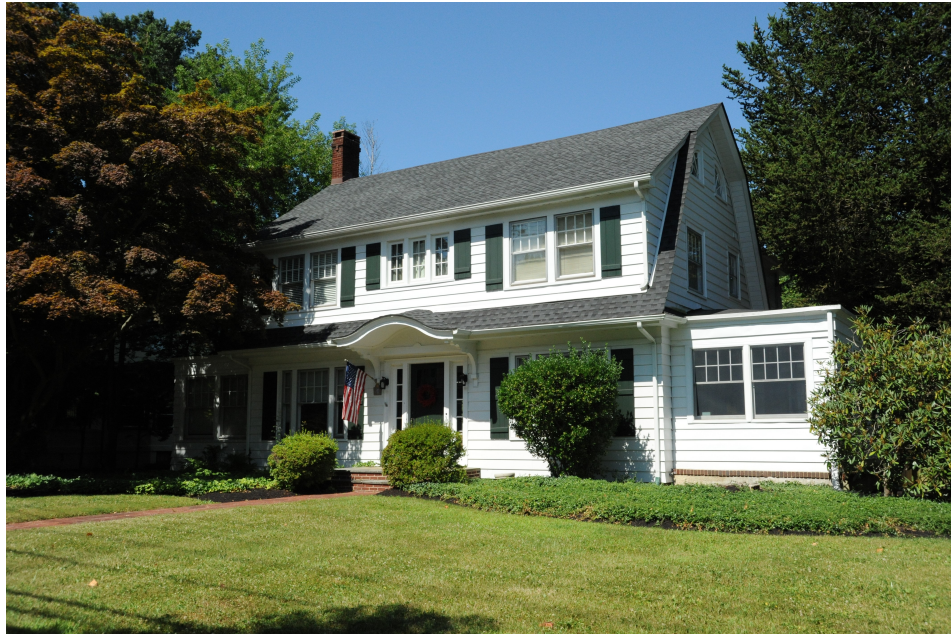
### Property Photo:

The 2 1/2-story, gambrel-roofed, rectangular-plan main block of this clapboard-clad, frame dwelling on a parged foundation is 5 bays wide and 2 bays deep and is backed on the northwest by a 2-story, gable-roofed, partial-width secondary volume offset on the northeast. The rear volume is in turn backed by a 1-story, composite-roofed rear el. The main block is flanked on the northeast and southwest by 1-story, composite-roofed historically enclosed porches. A large shed-roofed dormer spans most of the southeast roof slope. A 1-bay, shed-roofed oriel projects from the central bay of the northwest elevation. The roofs are predominantly clad in asphalt shingle. Exterior brick chimneys are centered on the gable of both the southwest elevation of the main volume and the northwest elevation of the rear volume. The windows predominantly have 8/1, historic wood sash, with historic paneled shutters on the main block's front elevation. The primary entrance of the residence, located in the central bay of the southeast elevation, includes a historic door with historic 5-light sidelights and a historic eyebrow-arched door hood on shaped brackets and a carved fan panel beneath the arch. The outer bays of the first floor are each lighted by a single window flanked on each side by a narrow, 2/1 sash window. The second floor is lighted by paired windows in the outer bays and fixed, triple, 6-light casement windows in the central bay. Both side volumes are lighted by paired windows. The northeast, side elevation, only partially visible from the public right-of-way, is lighted on the second floor by a window to the southeast and a smaller

window to the northwest, with 2 multi-light, quarter-round windows on the third floor. The southwest, rear elevation is regularly fenestrated and lighted in the side volume by 2 paired windows. The northwest, rear elevation is irregularly fenestrated with 8/1 and 6/1 windows. A secondary door to the rear el, located in the central bay, is accessed by a wood stair with a wrought iron rail and includes a 3-light transom. Another secondary entrance, located in the southwest bay, provides access to the basement. The northeast bay of the main block is lighted by a single window flanked by 1/1 windows. A door provides access to the northwest elevation of the northeast side volume. The historic, side gable-roofed, 2 bay garage, located to the southwest of the residence, includes shaped brackets supporting the roof overhang on the main, southeast elevation, and historic 9-light, paired folding doors flanked by fixed 9-light side panels. Historic 6/1 windows survive on the side elevations.

50 S. Main Street is a contributing property to the Cranbury Historic District because it retains integrity and historic, character-defining features such as its historic massing and fenestration patterns, historic window sash, historic door and door surround, historic siding material, and historic chimneys. The garage retains historic brackets, doors, and windows.
