## PROPERTY REPORT

**Property Name:** 54 South Main Street  
**Address:** 54 S MAIN ST

**Survey Name:** Cranbury Local Historic District Survey 2018

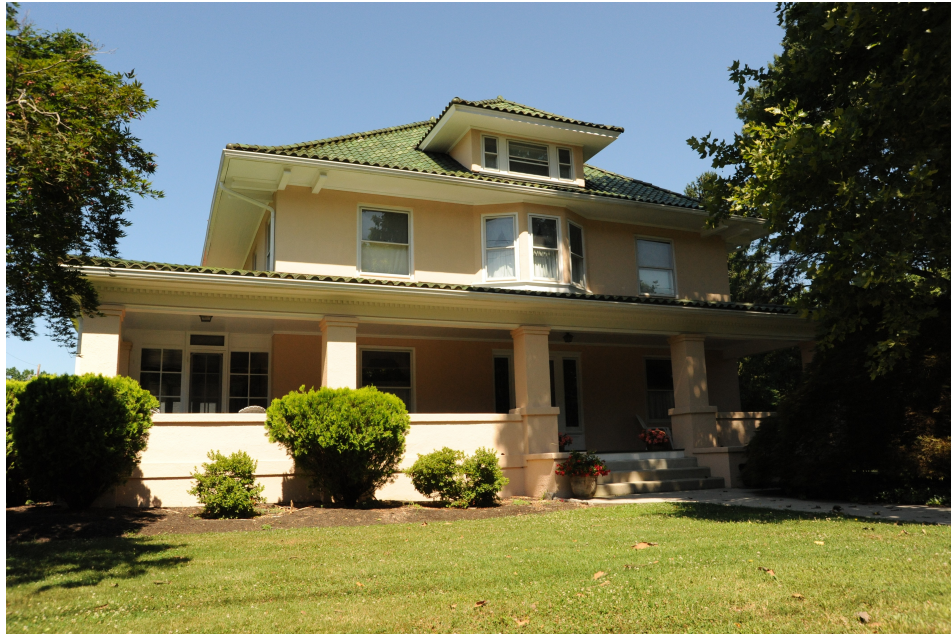
### Property Photo:

The 2 1/2-story, hip-roofed, foursquare main block of this stuccoed terra-cotta tile, Craftsman-style residence on a stuccoed foundation is 3-bays wide and 2 bays deep and is fronted on the southeast by a hip-roofed porch that wraps around the southeast bays of the southwest elevation with an enclosed section that retains historic window sash. A 3-sided projecting oriel is centered above the main door on the second floor of the southeast elevation. A 1-story rear el backs the main volume on the northeast side of the northwest elevation. A 1-story, hip-roofed, 3-sided bay projects from the northwest bay of the southwest elevation. The northeast and southwest roofs slopes include a hip-roofed dormer. An interior stuccoed chimney is located near the center of the northeast roof slope. The roofs of the main block and dormers include roof kicks and the roofs are clad throughout in historic terra cotta tile. Paired brackets articulate the corners of the main block. The windows predominantly have 1/1 historic wood sash. The front porch, accessed by a centered stair with stuccoed cheekwalls, includes square-plan, stuccoed pillars, a stuccoed knee wall, and a dentilled cornice. The primary, centered entrance includes a historic door with a large single light and historic, single-light sidelights over a recessed panel. The remaining bays of both floors are regularly fenestrated, with 3 windows lighting the second floor oriel. A single, wide 1/1 window flanked by smaller 1/1 windows lights the dormer. The enclosed porch is accessed by a central 6-light door flanked on each side by 6-light windows. The northeast, side elevation is

regularly fenestrated, with smaller windows in the central bay. The southwest, side elevation is lighted in the enclosed porch by 2 sets of triple 6-light windows. The enclosed porch partially covers the 3-sided bay. The second floor is lighted by paired and single windows, with a single window lighting the dormer. A secondary door provides access to the south elevation of the rear el. The northwest, rear elevation is not visible from the public right-of-way. The 2-bay, hip-roofed garage, located to the west of the residence, includes 2 sets of paired, 9-light doors and its historic terra cotta tile roof.

The residence at 54 S. Main Street contributes to the Cranbury Historic District because it retains integrity and historic, character-defining features such as its historic massing and fenestration patterns, historic door and door surround, historic windows, historic terra cotta roof tiles, historic chimney, and historic porch pillars and knee wall. The garage retains its historic roof tiles and historic garage doors.
