New Jersey Department of Environmental Protection Historic Preservation Office

PROPER	TY REPORT			Property ID: -743044053
Property Name:	27 North Main Street			Ownership: Private
Address:	27 N Main ST		Apartment #:	ZIP: 08512
PROPERTY LOC	ATION(S):			
County:	Municipality:	Local Place Name:	USGS Quad:	Block: Lot:

Survey Name: Cranbury CLG Survey 2017 Surveyor: Kristen Herrick Organization: RGA, Inc.

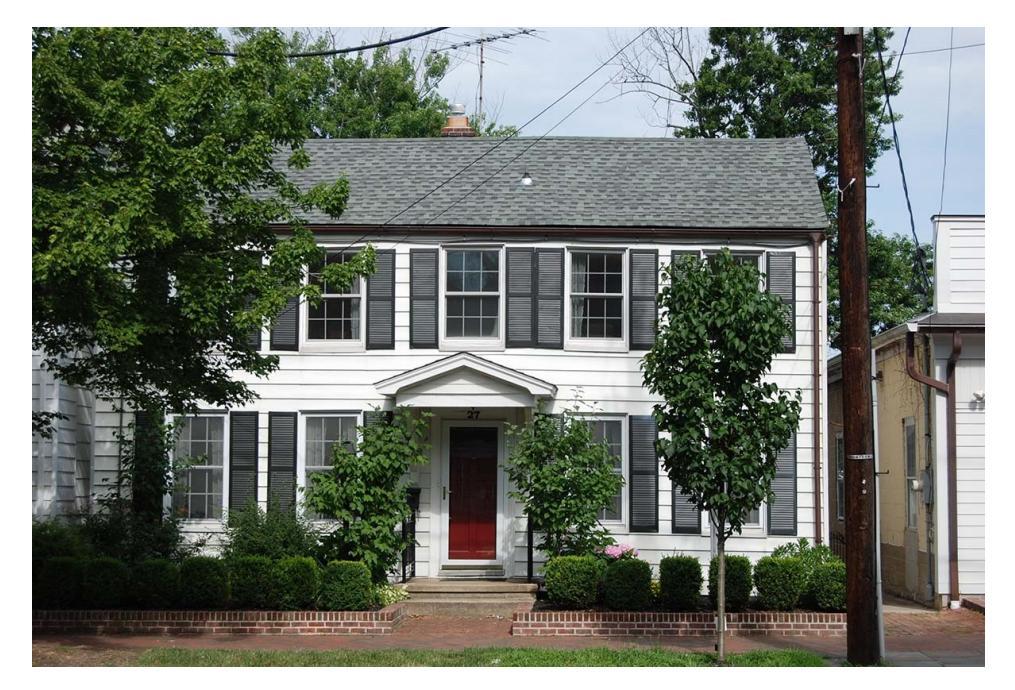
Property Photo:

27 North Main Street is a two-story, five-bay, one-pile vernacular residence constructed circa 1840. The building consists of a main block facing east onto North Main Street, a two-story rear addition, and a one-story addition on the rear of the two-story section.

The main block is the two-story section facing onto North Main Street. It has a side-gabled roof sheathed with asphalt shingles. The house has minimal eaves, with a flush rake on the end walls. The original chimneys have been removed; the remaining chimney is a brick element located in the two-story addition. The exterior of the dwelling is clad in aluminum siding. Fenestration is symmetrically arranged on the main elevation. Windows are six-over-six vinyl-sash (replacement) units within wood frames, flanked by louvered inoperable replacement shutters. The central entrance consists of a four-panel replacement door with a single semicircular light, opening below a shallow-sloped hood supported by triangular braces and accessed via a concrete pad porch with metal railings. The main block has a stone foundation.

The south elevation is barely visible, as the house stands so near the house to the south. The only opening in the aluminum-clad wall is an attic window. The north elevation has a similar appearance, it is a mostly solid aluminum-clad wall. The wall openings consist of a rank of windows near the northeast corner.
