PROPERTY REPORT

Property Name: 90 Halsey Reed Road
Address: 90 Halsey Reed RD

Survey Name: Cranbury Historic Sites Survey Phase III

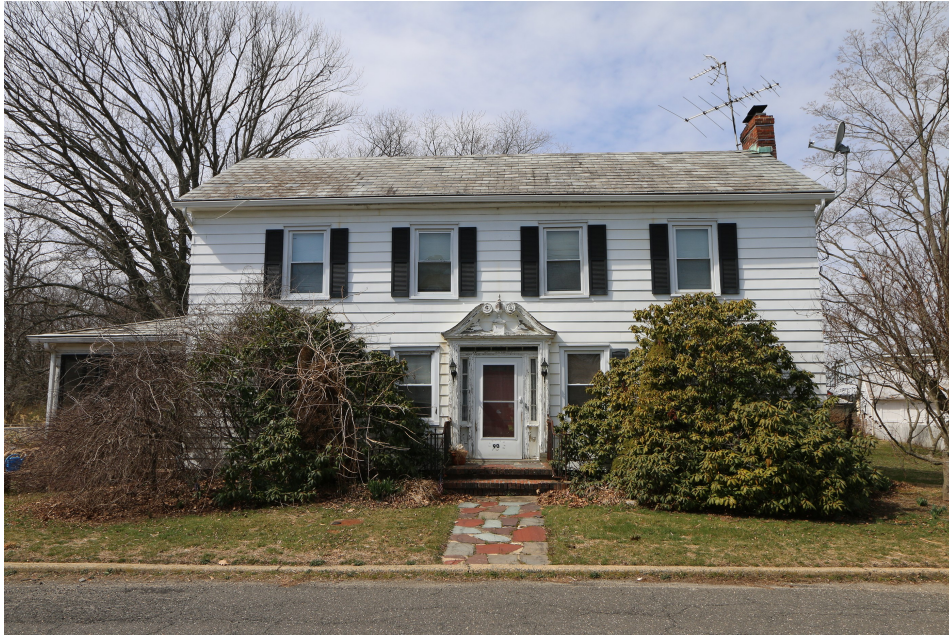
Property Photo:

90 Halsey Reed Road is a two-story-tall, four-bay-wide, two-bay-deep, frame dwelling built circa 1880 in the Greek Revival. The dwelling consists of a side-gabled main block, with a two-story, rear (west) ell and a hipped-roof, enclosed porch extending from the south elevation of the main block (likely added in the early twentieth century). The roof is sheathed in asphalt shingles. An exterior, brick chimney extends above the north gable end. The exterior of the dwelling is clad in aluminum siding. Windows throughout consist of one-over-one, vinyl-sash replacement units, flanked by inoperable vinyl shutters on the primary (east) elevation of the main block. The primary elevation has symmetrical fenestration. The central, primary entrance contains a metal storm door and wood panel door, set within a wood surround featuring a segmented transom and sidelights and topped by a broken pediment (historic, likely original). The entrance is accessed by a brick stoop with metal railings. The north elevation of the main block has symmetrical fenestration. The south gable end of the main block contains a louvered metal vent, with paired vinyl-sash windows on the first floor of the rear ell. The hipped-roof porch is enclosed with wood screen windows (possibly historic) and is supported by narrow wood columns. The rear elevation is not visible from the public right-of-way. The dwelling stands atop a fieldstone foundation.

Character-defining elements of the dwelling consist of its massing, wood frieze with gable-end returns, and wood door surround with a broken pediment.

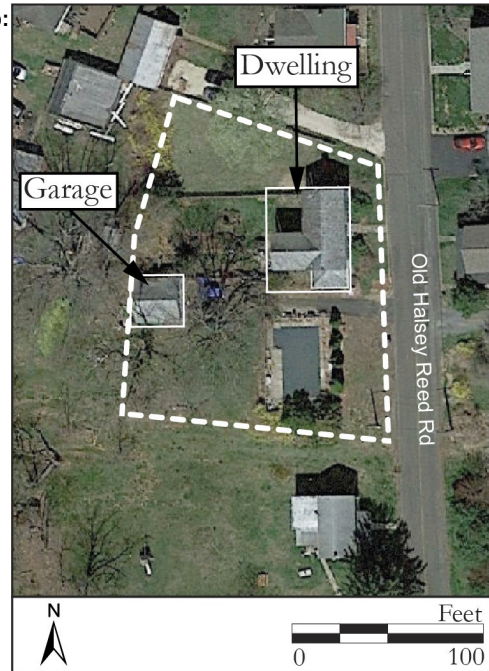
**Site Map:**

90 Halsey Reed Road is sited on two irregularly shaped parcels (Block 13, Lots 3 and 4) located on the west side of Halsey Reed Road in Cranbury Township, Middlesex County, New Jersey. The dwelling is oriented with its primary elevation facing east and is set back approximately 20 feet from the road. An asphalt driveway leads from the roadway to the garage and a flagstone path leads from the roadway to the primary entrance. Shrubs and hardwood trees are planted in close proximity to the dwelling. A wood fence borders the rear yard of the property. The subject property is located in a residential neighborhood surrounded by properties dating from the mid-nineteenth to the early twentieth centuries.
