PROPERTY REPORT

Property Name: 4 Station Road **Ownership:** Private
Address: 4 STATION RD **Apartment #:** **ZIP:** 08512

PS&S recommends that 4 Station Road, built ca. 1850, is a contributing property in the Cranbury Historic District.

Survey Name: Cranbury Local Historic District Survey 2018

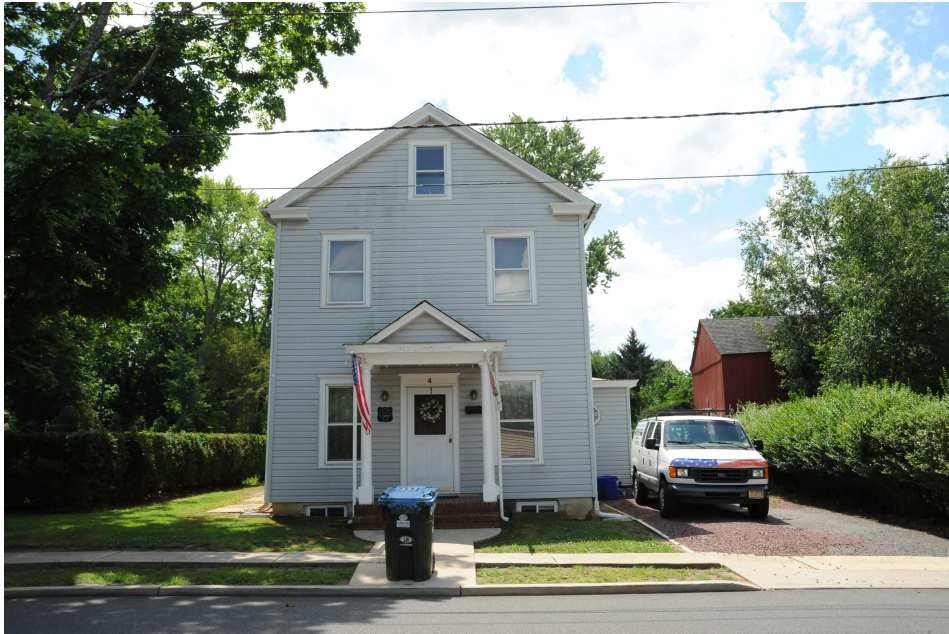
Property Photo:

The 2 1/2-story, gable-roofed, rectangular-plan main block of this vinyl siding-clad, frame residence on a parged stone foundation is 3 bays wide and 3 bays deep and is fronted on the north by a 1-story, 1-bay, centered, gable-roofed porch and is backed on the south by a 1-story, shed-roofed, full-width rear el that extends on the east as a shallow, gabled pavilion and is flanked on the west by a 1-story, hip-roofed and on the west recessed rear el that projects slightly beyond the east elevation. The rear el is flanked on the west by a 1-story, hip-roofed enclosed porch separated from the el by a roof parapet. An interior brick chimney is located towards the south of the east roof slope. The visible roofs are clad in asphalt shingle and the windows throughout have 1/1, historic replacement wood sash. The pedimented, 1-story front porch includes historic replacement columns. The primary entrance, accessed by the porch, includes a replacement single-light storm door and a paneled door. The remaining bays are regularly fenestrated with a single window on the third floor. The west, side elevation is regularly fenestrated with paired windows. The hip-roofed enclosed porch, only partially visible from the public right-of-way, includes a secondary entrance on its west elevation and a fixed, octagonal, single-light window on the north elevation. The east, side elevation is regularly fenestrated and includes a secondary entrance in the south bay of the main volume. The rear el is accessed by another door on its east elevation flanked on the north by a single window. The south, rear elevation is not visible from the public right-of-way.

4 Station Road is a contributing property in the Cranbury Historic District because it retains integrity and historic character defining features, such as its historic replacement window sash and historic replacement porch columns, and historic massing that dates to at least 1933. However, due to the limited extent of historic exterior materials, this status is marginal.
