PROPERTY REPORT

Property Name: 6 Station Road **Ownership:** Private
Address: 6 STATION RD **Apartment #:** **ZIP:** 08512

Survey Name: Cranbury Local Historic District Survey 2018

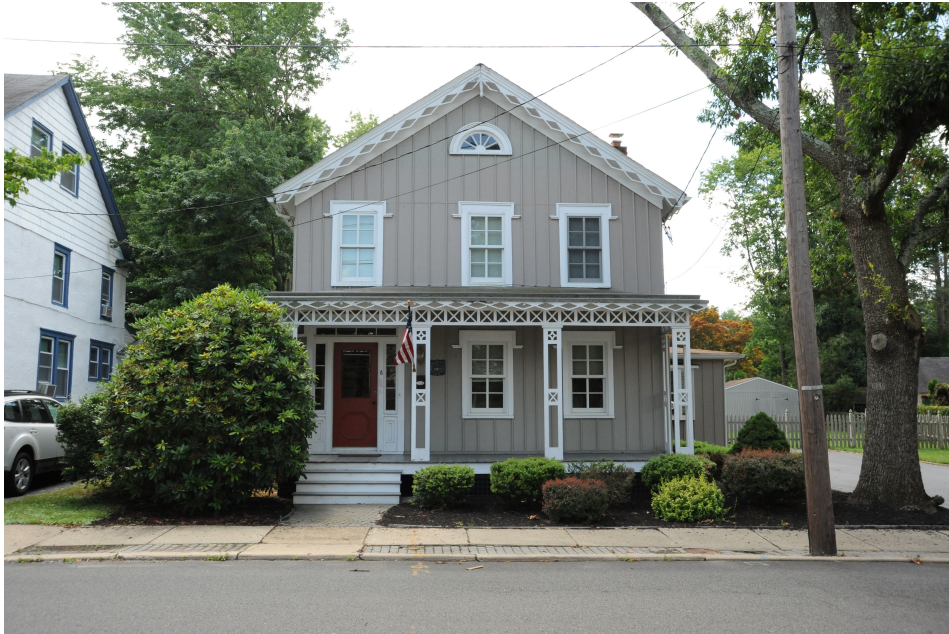
Property Photo:

The 2 ½-story, gable-roofed, rectangular-plan main block of this board and batten-clad, vernacular Gothic Revival frame dwelling on a parged foundation is 3 bays wide and 4 bays deep and is fronted on the north by a 1-story, hip-roofed, full-width porch and backed on the south by a 2-story, composite-roofed, full-width secondary volume. The rear volume is in turn backed by a 1-story, shed-roofed el. A 1-story, hip-roofed altered enclosed porch flanks the southern end of the main volume and el. An exterior brick chimney is centered on the west elevation of the main volume. The roofs are predominantly clad in asphalt shingle and the windows throughout have 2/2 replacement wood sash with historic Gothic labels. The rooflines of the main block, rear volume, and porch include historic bargeboards with an extended diamond, cut-out pattern. The front porch includes historic posts with decorative cut-out panels and a historic frieze with a cut-out "X" pattern divided by verticals. The primary entrance residence, located in the east bay of the north elevation, includes a single-light door and a historic door surround with 3-light sidelights over recessed panels and a 4-light transom. The remaining bays are regularly fenestrated on both floors, with a historic, 6-light fan-light on the third floor. The east and west, side elevations are regularly fenestrated in the main and rear volumes, except for the central, north bay of the side elevation. The altered side porch volume is lighted on its north elevation by a 3-sided bay window on brackets with 1/1 sash. A straight wood stair provides access to a multi-light door flanked by a single

window on the west elevation. The south, rear elevation is not visible from the public right-of-way. A 1-story, gambrel-roofed, frame, manufactured shed is located to the southwest of the residence.

6 Station Road is a contributing property in the Cranbury Historic District because it retains integrity and historic character-defining features such as its historic massing and fenestration patterns, its historic front porch, bargeboards, door surround, window labels, board and batten-siding, and brick chimney.
