PROPERTY REPORT

Property Name: 24 Station Road
Address: 24 STATION RD

Survey Name: Cranbury Local Historic District Survey 2018

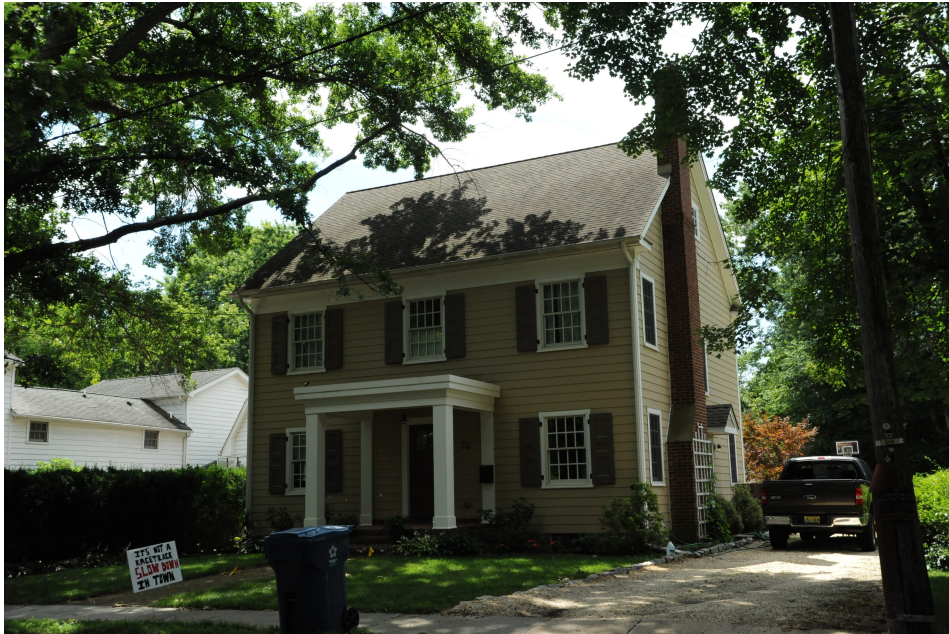
Property Photo:

The 2 1/2-story, side gable-roofed, rectangular-plan main block of this composite siding-clad, frame dwelling on a parged foundation is 3 bays wide and 2 bays deep and is fronted on the north by a 1-story, flat-roofed, central, 1 bay porch and backed on the south by a 2-story, gable-roofed, central volume. An exterior brick chimney is located towards the north of the east elevation. The roofs are predominantly clad in asphalt shingle, and the windows predominantly have 8/8 replacement wood sash with paneled shutters. The front porch includes square-plan pillars and a simple entablature. The primary entrance to the residence, accessed by the porch, includes a replacement door with 2 stained glass lights. The remaining bays are regularly fenestrated. The west, side elevation is asymmetrically fenestrated and includes a central, secondary entry with a gabled door hood. The east, side elevation is regularly fenestrated. The south, rear elevation is not visible from the public right-of-way. A 2-story, board and batten-clad outbuilding with a flanking 1-story, standing seam metal-roofed garage is located to the southwest of the residence.
