## PROPERTY REPORT

**Property Name:** Old Potato Farmhouse **Ownership:** Private  
**Address:** 1-3 CRANBURY NECK RD **Apartment #:** **ZIP:** 08512

**Survey Name:** Cranbury Local Historic District Survey 2018

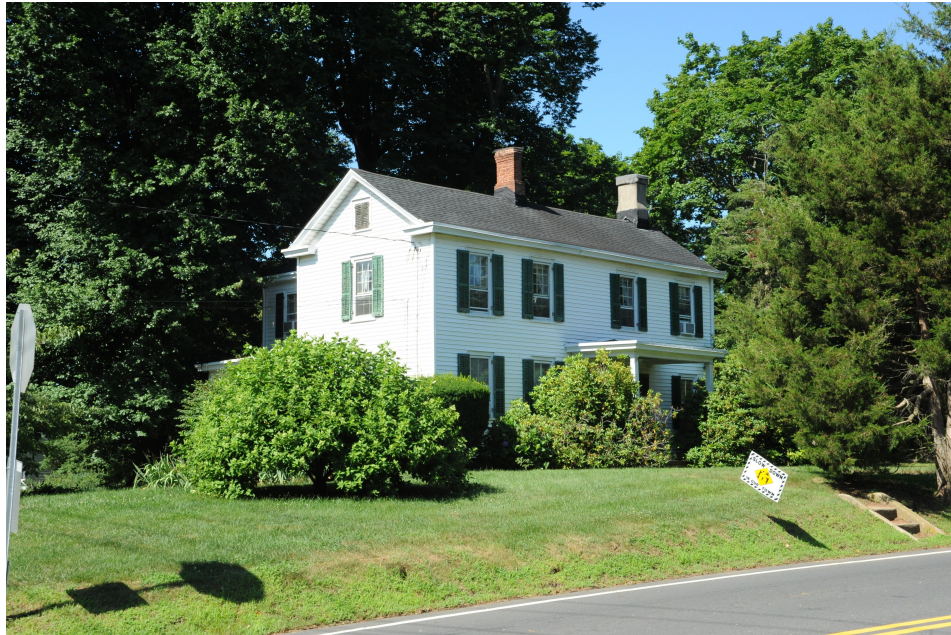
### Property Photo:

The 2-story, side gable-roofed, vinyl siding-clad main block of this frame dwelling on a concrete foundation is 5 bays wide and 2 bays deep, and is fronted on the northeast by a roughly centered, 1-story, hip-roofed entry porch and backed on the southwest by a 2-story, gabled rear volume. This is flanked on the southeast by a 1-story, composite-roofed side porch and flanked on the northwest by a 1-story side, shed-roofed porch that is partially recessed under the secondary volume. A 1-story, shed-roofed side volume flanks the main volume on the northwest. The roofs of the main volume and 1-story side volume are clad in asphalt shingle with cornice returns at the gable ends. A brick, interior, ridge chimneys is located near the center of the main roof and a stuccoed ridge chimney is near the northwest end of the main volume. The windows throughout include historic, louvered shutters and contain historic wood sash in 9/6 and 2/2 configuration. The front porch, on a brick and concrete base, includes historic, square-plan wood posts. The main entrance includes a 2-light, historic door. Each of the four flanking bays have a window on both floors, with the 9/6 sash on the second floor and 2/2 sash on the first floor. The northwest, side elevation is only partially visible from the public right-of-way and is fenestrated on the second floor of the main block by a

9/6 window in the northeast bay. The second floor of the rear volume is fenestrated in 2 6/6 or 6/1 windows. The side volume is lighted by a single window. The southeast, side porch includes replaced, historicized posts, balusters, and trim. The main volume is lit by 1 roughly centered window per floor with a 9/6 over a 2/2. The rear volume windows are 2/2. The side entrance, in the northeast bay of the rear volume, is located in the northeastern bay. The southwest elevation, only partially visible from the public right-of-way, includes 2/2 windows. In the secondary volume.

This property is a contributing property in the district because it retains integrity and historic, character-defining features such as its historic massing and fenestration patterns, historic wood window sash, historic porches, and historic chimneys.
