PROPERTY REPORT

Property Name: Elizabeth Debow House
Address: 17 N Main ST
Apartment #:
Ownership: Private
ZIP: 08512

Survey Name: Cranbury CLG Survey 2017

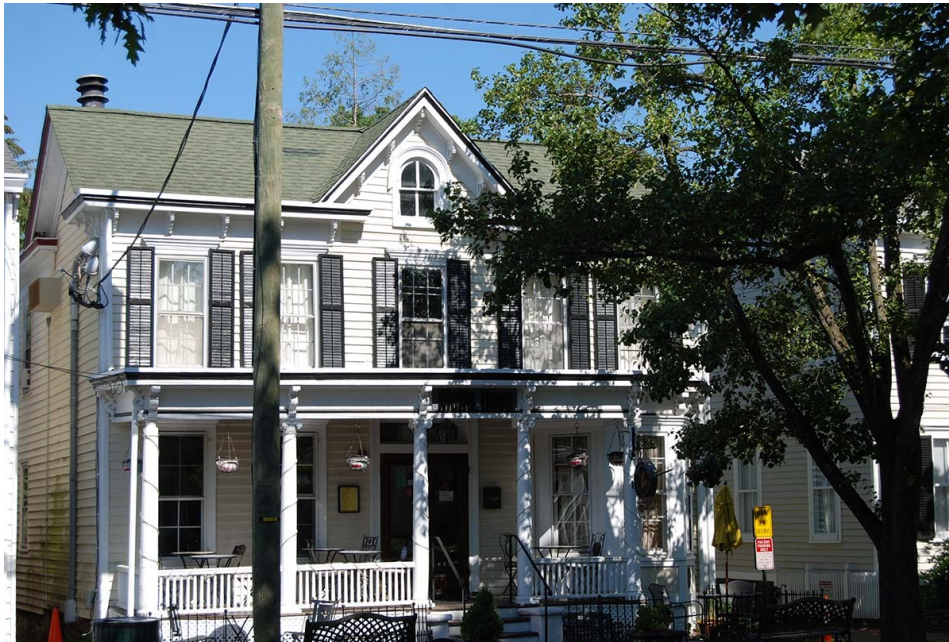
Property Photo:

The Elizabeth Debow House at 17 North Main Street is a two-and-a-half-story, five-bay, one-pile Gothic Revival style commercial building constructed circa 1850. The building currently houses a restaurant; it has a two-story rear addition on the rear and a one-story addition further west.

The building has a cross-gabled roof created by a centered cross-gable, which features an arched headed two-over-two wood sash window (possibly original). The roof is clad with asphalt shingles. A stove pipe is located near the south end of the ridge in the location of an original chimney. The molded cornice acts as an interior gutter system; it is supported by a row of thin brackets attached to a wood frieze. The wall surface is clad with wood clapboard siding. Fenestration is symmetrical. Windows are primarily six-over-six wood sash units (possibly original) with louvered shutters on the second floor. The front porch extends along the entire elevation; it has a flat roof, molded cornice, thick brackets, and five Ionic columns (connected by a low railing with square balusters) supporting the porch eaves. An octagonal bay on the porch is aligned with the north end wall; it has a four-over-four window on each panel (possibly original). The central entrance consists of paired, one-light wood panel doors topped by a transom in a molded surround.

The north end wall faces onto a narrow passageway with the neighboring building. The extended eaves supported by the shaped brackets is visible above, along with the cornice returns. The wall surface is clad with vinyl siding. The elevation has a single rank of replacement

one-over-one windows near the northeast corner, located below the cornice return. The south elevation is a solid vinyl-clad wall below the molded cornice with shaped brackets and cornice returns.

The two-story rear addition extends along the entire rear (west) elevation of the main block. It has a gabled roof with extended eaves on the north and south side walls. The frame walls are clad with vinyl siding. Fenestration is asymmetrically spaced; windows are replacement one-over-one double hung sash units, with two ranks on the south elevation and one on the north. On the rear of this two-story addition is a one-story addition that is not visible from the public right-of-way.

Character-defining elements of the building include a bracketed cornice, a one-story full-façade porch with a bracketed cornice and Ionic columns, and a central cross-gable.
