New Jersey Department of Environmental Protection Historic Preservation Office

PROPERTY REPORT

Property Name: 5 Bunker Hill Drive Ownership: Private 5 Bunker Hill DR **ZIP:** 08512 Address: Apartment #:

Survey Name: Cranbury CLG Survey 2017

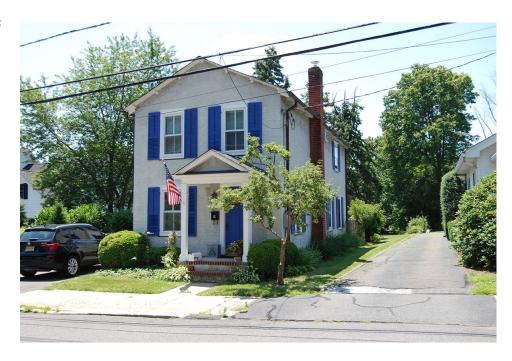
Property Photo:

5 Bunker Hill Drive is a two-story tall, two-bay wide, four-bay deep, frame private residence constructed circa 1915 in a vernacular style. The dwelling, which sits on a concrete foundation, has a rectangular footprint no additions. The front-gabled roof is sheathed in asphalt shingles and features delicate ogee brackets below the overhanging eaves. An exterior brick, capped chimney punctures the roof on the southwest elevation. The exterior of the dwelling is covered with stucco. Windows on the first and second floors of the front elevation are two-over-two, double-hung wood-sash (likely original) with molded wood surrounds and louvered shutters. The historic entrance, a typical six-light cottage door (two tall vertical panels below two rows of inset lights), sits in the west bay on front elevation. A front-gabled entry porch with square posts (added to the dwelling after 1933) shelters the entrance, which is accessed via a concrete stoop trimmed with bricks. The northwest and southeast elevations feature two-over-two, double-hung, wood-sash windows (likely original) with molded wood surrounds and louvered shutters in an asymmetrical arrangement. A secondary entrance consisting of a single door sheltered by a frontgabled hood supported by brackets, is located in the south bay on the southeast elevation. The rear elevation is not visible from the public right-of-way. Character-defining elements of the dwelling include wood-sash windows and ogee brackets supporting overhanging eaves. A one-story, front-gabled frame garage, constructed circa 1930, stands south of the dwelling.
