PROPERTY REPORT

Property Name: 49 North Main Street

Survey Name: Cranbury CLG Survey 2017

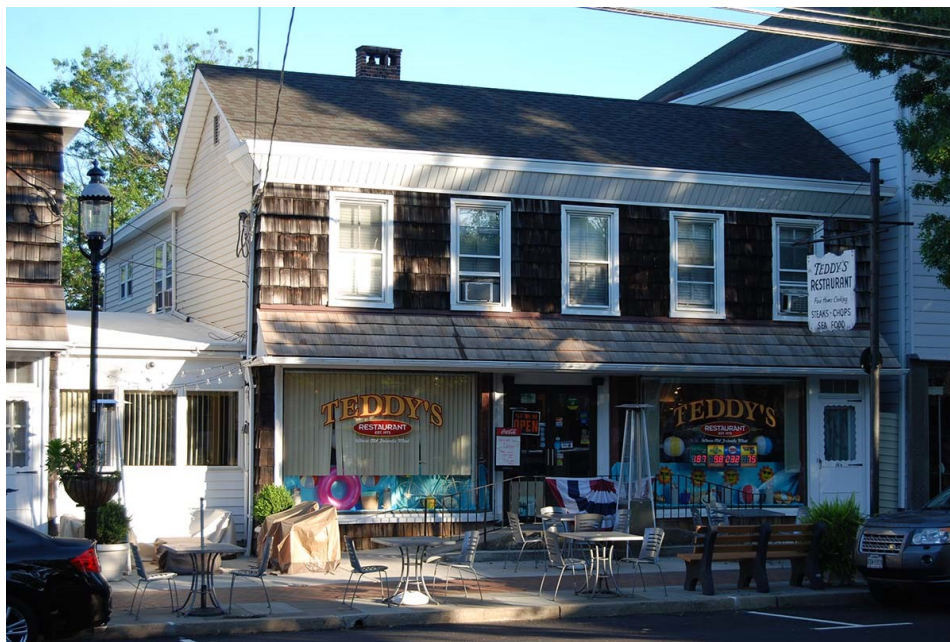
Property Photo:

49 North Main Street is a two-story, five-bay, one-pile, frame former private residence constructed circa 1860. The building currently serves as commercial space on the first floor with apartments on the second floor. The rectangular building is connected to the building at 43 North Main Street via a one-story addition to the south and abuts the building at 55 North Main Street to the north. The side gabled roof is sheathed with asphalt shingles and features vinyl-clad eaves. An interior brick chimney pierces the roof on the rear addition. The walls are frame, clad with wood shingles on the main elevation. The second floor features five two-over-two wood sash windows (possibly original), arranged symmetrically over a pent roof. The first floor features large display windows and replacement entrances. The door into the store is located near the center of the building; it is a paired glass door that is slightly recessed. The door to the second floor is located in the north bay and opens under a segmented transom.

The south elevation is a mostly solid frame wall clad with vinyl siding. A small attic window is located in the vinyl-clad eaves.

The one-story wing attaching the building to the building at 43 North Main Street is a one-story, three-bay section aligned with the main (east) elevation of 49 North Main Street. Its end-gabled roof is clad with asphalt shingles. The walls are frame, clad with vinyl siding and containing three plate glass windows.
