PROPERTY REPORT

Property Name: George Morris House

Address: 31 N Main ST

Survey Name: Cranbury CLG Survey 2017

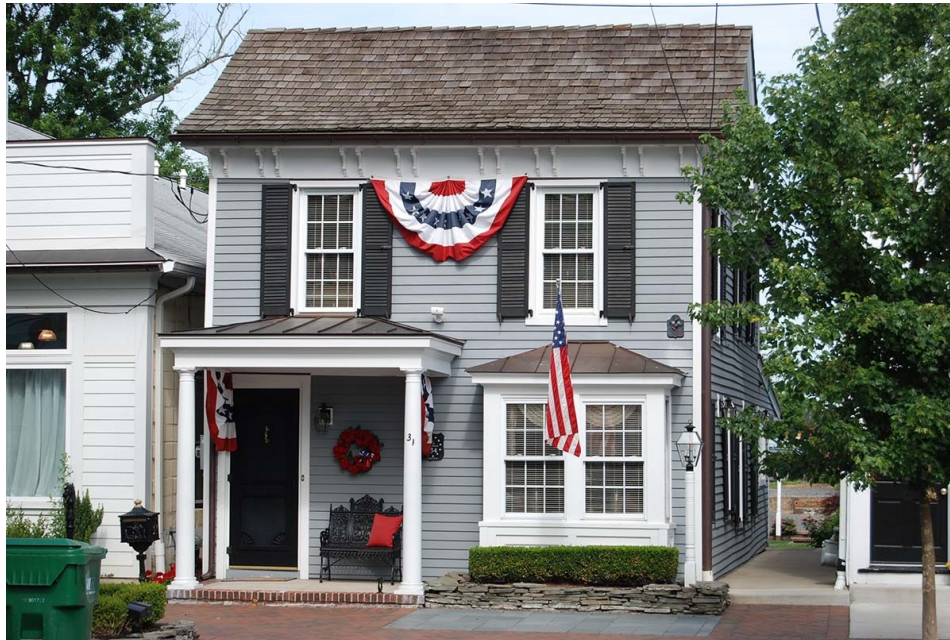
Property Photo:

The George Morris House at 31 North Main Street is a two-story tall, two-bay wide, two-bay deep, frame private residence constructed in 1834. The dwelling consists of a rectangular, side-gabled main block with a two-story, two-bay addition and a one-story, one-bay shed roof addition to the rear (both constructed by 1916). The roof is sheathed with asphalt shingles. An interior brick chimney pierces the roof on the southwest bent of the two-story rear addition. The roof is sheathed with wood shingles with a return cornice at the gable ends of the main block. The slightly overhanging eaves are supported by brackets. The exterior of the dwelling is clad in Hardi-Plank siding. A wood frieze runs beneath the eaves on the front elevation. The two windows on the second floor of the front elevation are six-over-six, vinyl-sash replacement windows with louvered shutters. A square projecting bay window, with six-over-six vinyl-sash windows and a hipped standing steam copper cap, sits in the north bay on the first floor. The entrance, located beside the bay window, is a single four-panel wood door with a vinyl storm door. The entrance is sheltered by a one-story entry porch with a hipped standing steam copper roof and unfluted Doric columns. Access is gained via a concrete stoop with rowlock brick trimmers. The northwest elevation features six-over-six, vinyl-sash replacement windows with louvered shutters on the second floor and paneled shutters on the second floor. The southeast and rear elevations are not visible from the public right-of-way. Character-defining elements of the dwelling include the bracketed cornice and one-story entry porch.
