PROPERTY REPORT

Property Name: United Methodist Church of Cranbury
Address: 21 N Main ST

Survey Name: Cranbury CLG Survey 2017

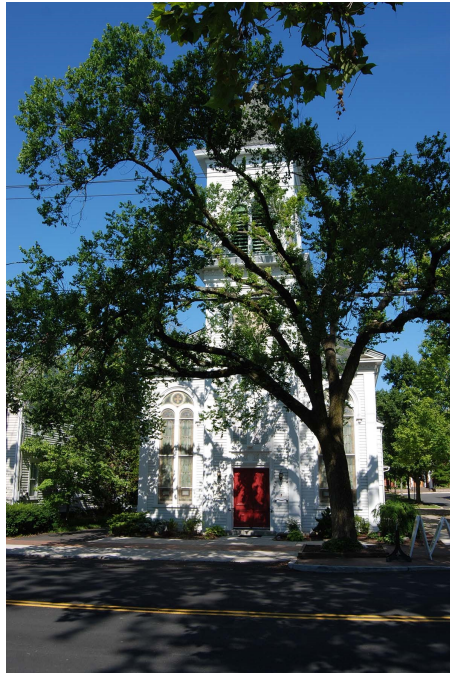
Property Photo:

United Methodist Church of Cranbury at 21 North Main Street is a two-story, three-bay, four-pile, frame church constructed in 1848 and renovated in 1868 in the Gothic Revival tradition. The building has a large rear addition.

The church building consists of a front-gabled rectangular chapel plan building with an engaged entry tower and the rear addition. The roof is sheathed with asphalt shingles and features a return cornice on the front that creates a pediment. An expressed frieze includes a decorative wave feature. The wall surface is clad with wood clapboards. Large arched headed stained glass windows flank the tower; each window consists of two arched headed windows and an upper pane, with the window assembly located below an expressed drip mold.

The semi-engaged entrance tower dominates the view of the main elevation. The first floor contains a paired entrance with two Italianate style doors with an arched-headed upper panel and a square lower panel. Above the entrance, the second floor of the tower consists of a large louver located below an arched drip course and over four square tile. The tower's third floor is the belfry, which features a paired arched-headed louver on each wall above a cornice with dentils and a wavy frieze. The upper portion of the tower is the spire, a pyramidal-shaped element clad with asphalt shingles and featuring flared eaves.
