PROPERTY REPORT

Property Name: Wm. Schanck House

Address: 12 S MAIN ST

Survey Name: Cranbury Local Historic District Survey 2018

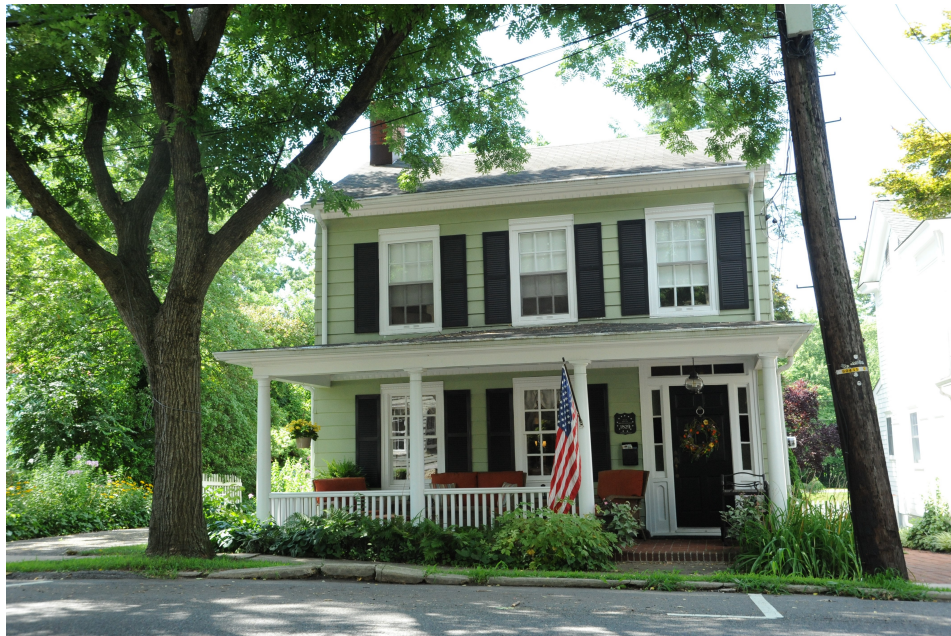
Property Photo:

The 2-story, gable-roofed, rectangular-plan main block of this aluminum siding-clad, frame dwelling on a parged foundation is 3 bays wide and 5 bays deep and is fronted on the southeast by a 1-story, hip-roofed, full-width porch and backed on the northwest by a 2-story, partial-width, gable-roofed secondary volume. A 1-story, shed-roofed volume flanks the depth of the rear volume on the southwest elevation. The roofs are predominantly clad in asphalt shingle and the windows predominantly have 6/6 historic wood sash with a dentil course at the top of the lintel and applied shutters. An interior brick chimney projects from the southwest bay of the gable ridge of the main block. A second interior brick chimney projects from the northwest bay of the gable ridge of the rear volume. The front porch, located on the southeast, main elevation, includes replacement columns and a historic rail with square-plan balusters. The primary entrance, located in the northeast bay, includes a historic replacement door and a historic door surround with 3-light side lights over recessed segmental arch panels and a 3-light transom. The remaining bays of both floors are regularly fenestrated. The northeast, side elevation is lighted by a single window in the northwest bay of the main volume. A 4-light casement window is under the gable eaves. The rear volume is lighted by 2 windows on both floors in northwest bays and a single, smaller window on the first floor. The southwest, side elevation, only partially visible from the public right-of-way, includes a secondary entrance in the northwest bay and is lighted by 2 windows on both the first and second floor. The

southwest elevation of the main block is lighted by a single window on the second floor of the northwest bay and on the first floor of the southeast bay. The northwest, rear elevation is not visible from the public right-of-way. A 1-story, gable-roofed, 2-bay, frame garage with a shed-roofed side volume on the southwest elevation is located to the northwest of the residence.
