PROPERTY REPORT

Property Name: 2 Symmes Court **Ownership:** Private
Address: 2 SYMMES CT **Apartment #:** **ZIP:** 08512

Survey Name: Cranbury Local Historic District Survey 2018

Organization: Paulus, Sokolowski & Sartor

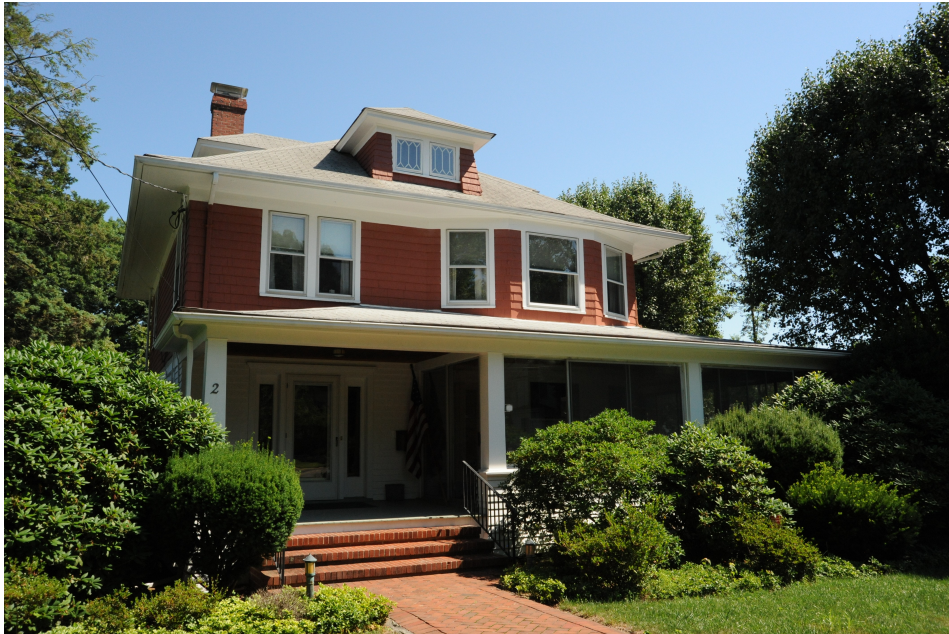
Property Photo:

The 2 1/2-story, hipped-roofed, foursquare main block of this clapboard and painted wood shingle-clad, frame dwelling on a covered foundation is 3 bays wide and 2 bays deep and is fronted on the south by a 1-story, hipped-roofed porch that wraps around the east, side elevation and backed on the north by a 1-story, composite-roofed, full-width rear el. 2-story, 3-sided projecting bays are located in the east bay of the south elevation and the north bay of the east elevation. The east, south, and west top roof slopes are lighted by hipped-roofed dormers with slightly splayed sidewalls and a recessed central window bay that retains a historic paired multi-light extended, lozenge-pattern casement window. The roof of the main volume includes a roof kick and deep eaves. An interior brick chimney projects north of the dormer on the west roof slope. The roofs are predominantly clad in asphalt shingle and the windows predominantly have 1/1, historic wood sash. The first floor is clad in clapboard and the second floor and dormers are clad in painted wood shingle. The primary entrance, located in the west bay of the south elevation, includes a large single-light door and single-light sidelights. The porch, which is screened in all bays but the entry bay and obscures most of the first floor, is accessed by a straight stair to the entry bay and includes a clapboard-clad knee wall and square-plan posts. The second floor is regularly fenestrated with a paired window in the west bay. The east and west side elevations are regularly fenestrated. A secondary entrance to the porch is located in the north bay of the east elevation. The north, rear elevation is not visible from the public right-of-way. A 1-story, hipped-roofed concrete block garage is located to the northeast of the

The residence at 2 Symmes Court is a contributing property to the Cranbury Historic District because it retains integrity and historic character-defining features such as its historic massing and fenestration patterns, historic window sash, historic siding materials, and historic porch posts. The garage retains its historic massing and historic surface materials.
