New Jersey Department of Environmental Protection Historic Preservation Office

#### 1156447125 **PROPERTY REPORT** Property ID: Ownership: Private Property Name: 14 Symmes Court Address: 14 SYMMES CT **ZIP:** 08512 Apartment #: **PROPERTY LOCATION(S):** County: **Municipality:** Local Place Name: USGS Quad: Block: Lot: MIDDLESEX Cranbury township 23 92

Survey Name:	Cranbury Local Historic District Survey 2018		Property ID:	Page 1
Principal Investigator:	Emily Cooperman	(Primary Contact)	1156447125	
Organization:	Paulus, Sokolowski & Sartor

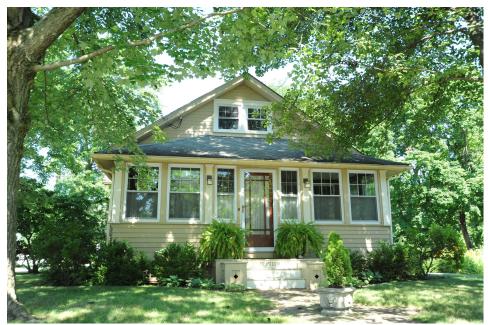
Property Photo:

The 1 ½-story, gable-roofed, rectangular-plan main block of this clapboard-clad, frame bungalow on a quarry-faced concrete block foundation is 3 bays wide and 3 bays deep and is fronted on the east by a 1-story, hip-roofed, enclosed front porch and backed on the west by a 1-story, hip-roofed rear el. A gable-roofed oriel projects from the central bay of the south elevation and gable-roofed dormer projects from the central bay of the north roof slope. The roofs are clad in asphalt shingle and the windows predominantly retain 3/1 historic wood sash, though the porch enclosure and the second floor of the main and rear elevations are lighted by a double window with 6/1 added or replacement sash. An interior brick chimney is located towards the west of the south roof slope. The primary entrance to the residence, located in the central bay of the east, main elevation and accessed by a straight wood stair with frame cheek walls, includes a replacement, multi-light door with a large central light. The door is flanked by narrow, 6/1 windows. The remaining bays of the porch are lighted by double windows. The porch includes a clapboard-clad knee wall and the bays are articulated by rectangular-section pilasters. The north, side elevation is lighted in the east bay by a double window, in the central bay by a single window. The dormer is lighted by 2 single windows. The south, side elevation is lighted by 2 single windows. The south, side elevation is lighted by double window in the projecting oriel. The west, rear elevation includes a secondary entrance on the north elevation of the rear el and is

lighted in the real el by a 3-sided projecting bay window. The main block is lighted by a single window on the first floor.

A 1-story, gable-roofed, frame, north-south oriented garage, clad in painted wood shingle and vinyl siding, is located to the west of the residence and includes exposed rafter tails and replacement, 10-light, segmental garage doors and a historic, 9-light door.

Symmes Court, named for a local parson, occupies land previously owned by the Presbyterian Church and sold and planned for subdivision in 1894. The 1980 National Register of Historic Places Nomination for the Cranbury Historic District reports that the 1 ½-story, gable-roofed dwelling at 14 Symmes Court was constructed by "Perrine" in 1929. The residence is recorded on the 1933 Sanborn map as 1-story, frame dwelling with a 1-story front porch, a shallow, projecting side bay, a rear el, and a 1-story garage. The 1974 photographic inventory of Cranbury historic buildings in the collection of the Cranbury Historical and Preservation Society shows the residence with aluminum siding and an enclosed front porch. Visual evidence suggests that the door to the enclosed porch has been replaced within the last ten years.

14 Symmes Court is a contributing property in the Cranbury Historic District because it retains integrity and historic, character-defining features such as its historic massing and fenestration patterns, historic window sash, and historic chimney. The garage retains its historic massing, historic painted wood shingle, and exposed roof rafter tails.
