PROPERTY REPORT

Property Name: 127 North Main Street

Survey Name: Cranbury Historic Sites Survey Phase III

Organization: Richard Grubb & Associates, Inc.

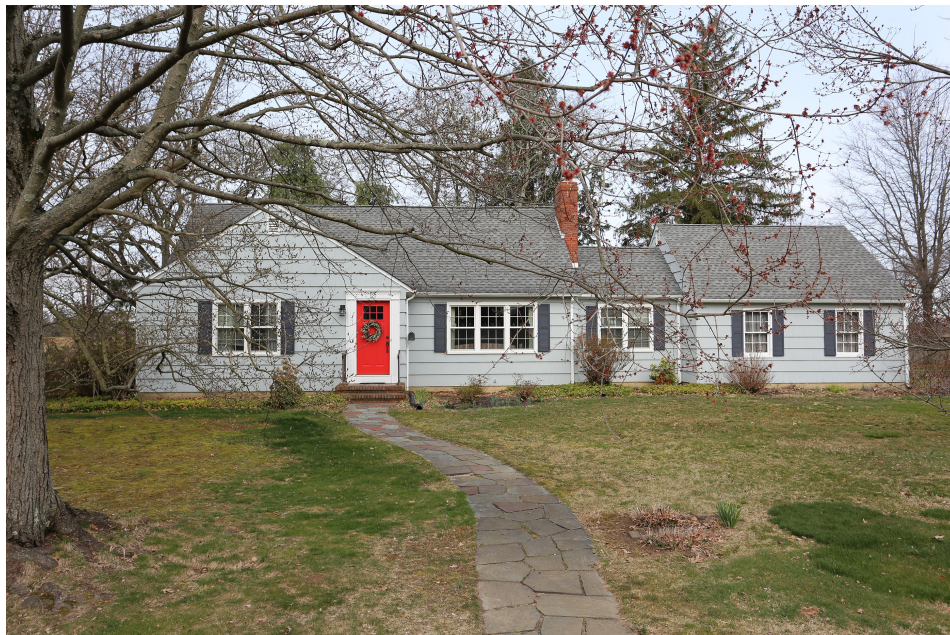
Property Photo:

127 North Main Street is a one-and-one-half-story-tall, three-bay-wide, three-bay-deep, frame dwelling built circa 1951 in the Minimal Traditional style. The dwelling consists of a three-bay-wide, side-gable-and-wing main block with a one-story-tall, two-bay-wide, attached garage connected to the northeast of the main block by a central, one-story-tall, one-bay-wide wing. A shed-roof dormer projects from the rear (northwest) roof slope of the main block and an exterior brick chimney extends above the northeast gable end of the main block. The roof is sheathed in asphalt shingles. The exterior of the dwelling is clad in machined shingles. Metal louvered vents are located in the northeast and southwest gable ends of the main block. Windows consist of six-over-six, vinyl-sash replacement units flanked by inoperable, louvered vinyl shutters throughout. Located in the center bay of the main block and below the front-gabled wing, the primary entrance contains a six-light vinyl sash door set within a wood surround with fluted pilasters (historic, likely original). A small brick stoop with metal handrails provides access to the entrance. A secondary entrance with wood steps is located on the rear elevation of the central wing but was not readily visible from the public right-of-way. The dwelling sits atop a concrete foundation.

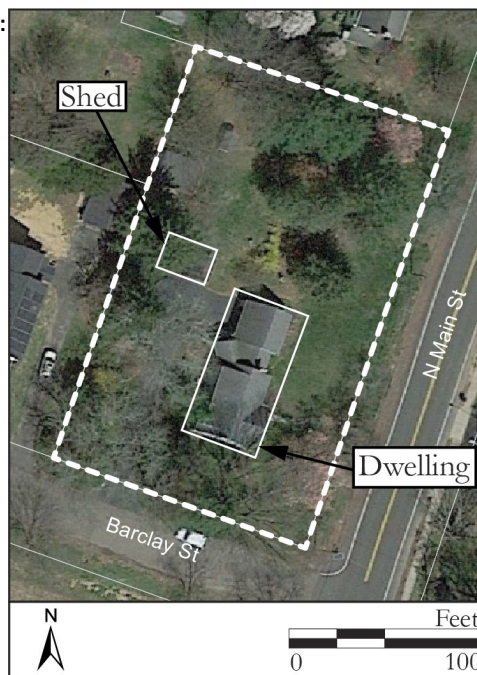
Site Map:

127 North Main Street is sited on a rectangular parcel (Block 25, Lot 23) located on the northwest side of North Main Street, at the northwest corner of its intersection with Barclay Street, in Cranbury Township, Middlesex County, New Jersey. The dwelling is oriented

with its primary elevation facing southeast and is set back approximately 60 feet from North Main Street. An asphalt-paved driveway extends along the northwest border of the property. A stone path leads from North Main Street to the primary entrance. Mature trees and shrubs are planted within close proximity to the dwelling. The subject property is located in a residential neighborhood surrounded by properties dating from the mid-nineteenth to the late twentieth centuries.
