# PROPERTY REPORT

**Property Name:** 111 North Main Street **Ownership:** Private  
**Address:** 111 N Main ST **Apartment #:** **ZIP:** 08512

**Survey Name:** Cranbury Historic Sites Survey Phase III

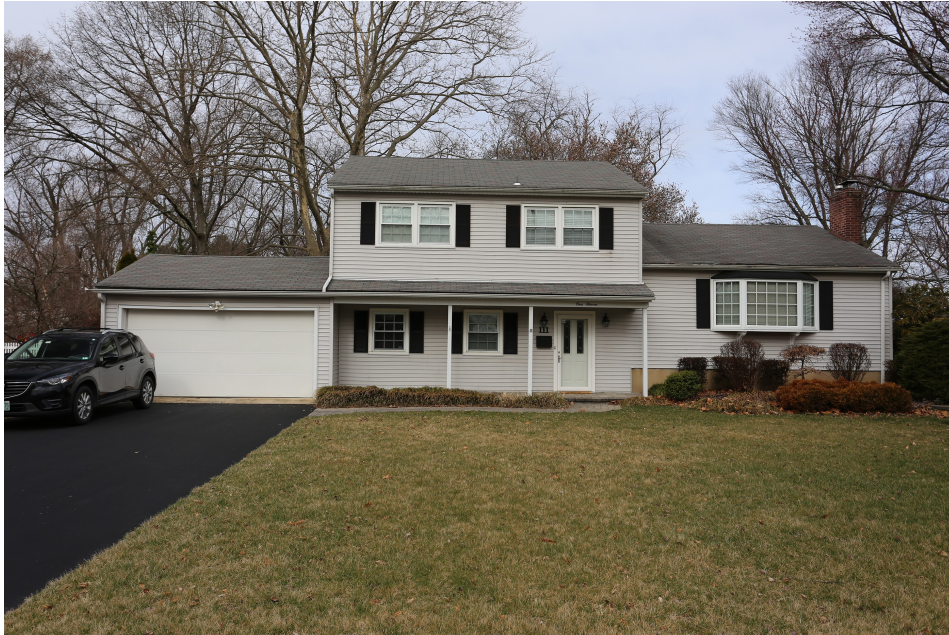
## Property Photo:

111 North Main Street is a two-story-tall, four-bay-wide, three-bay-deep, frame, Tri-Level Split dwelling built in 1963. The dwelling consists of a two-story, side-gabled main block with a one-story, side-gabled wing to the northeast and a one-story, side-gabled, attached garage to the southwest. An exterior brick chimney rises above the northeast gable end of the northeast wing. Metal louvered vents are located in the gable ends of the main block, northeast wing, and garage. The roof is sheathed in asphalt shingles. The exterior of the dwelling is clad in vinyl siding. Windows are primarily single and paired, six-over-six, vinyl-sash replacement units, flanked by inoperable, louvered vinyl shutters on the primary (southeast) elevation, with the second floor slightly overhanging the first floor. A one-story, shed-roof porch with square wood posts extends along the main block's primary elevation. Located in the northeast bay of the main block, the primary entrance features a glazed metal storm door and a vinyl panel door with two vertical lights. A central hipped-roof vinyl bay window, supported by two brackets, is centered on the northeast wing's primary elevation. A single, metal roll-top door is located on the garage's primary elevation. The rear (northwest) elevation is not visible from the public right of way. The dwelling stands on a parged foundation.
