PROPERTY REPORT

Property Name: 109 North Main Street **Ownership:** Private
Address: 109 N Main ST **Apartment #:** **ZIP:** 08512

Survey Name: Cranbury Historic Sites Survey Phase III

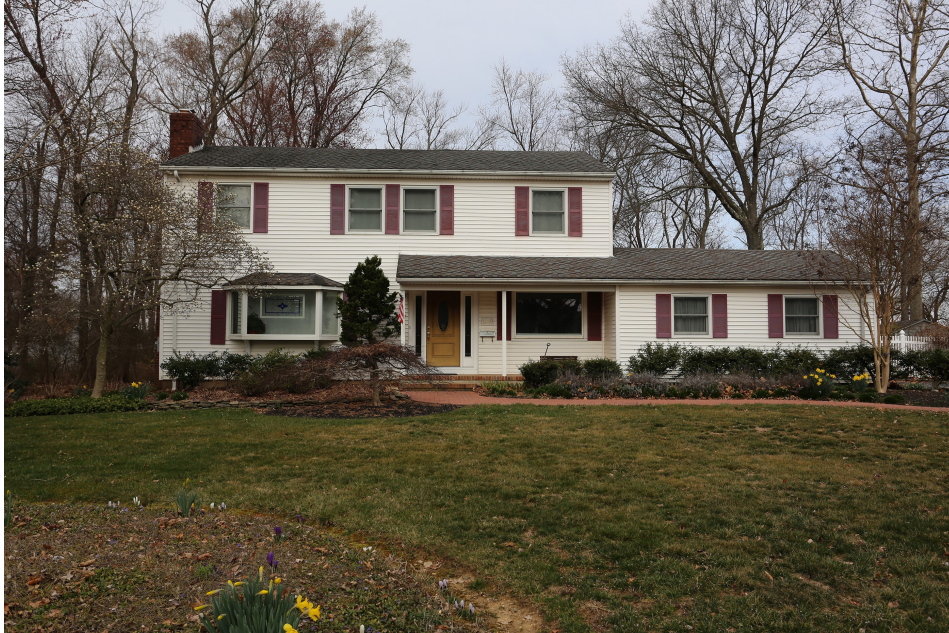
Property Photo:

109 North Main Street is a two-story-tall, three-bay-wide, two-bay-wide, frame dwelling built in 1963. The dwelling consists of a side-gabled main block with an attached garage on the northeast elevation; a two-story, gable-roof, rear (northwest) addition (added circa 2005), and a one-story-tall, gable-roof, rear addition (added circa 2014). A small, one-story, shed-roof wing projects from the southwest elevation of the main block. An exterior brick chimney rises above the southwest gable end of the main block. The roof is sheathed in asphalt shingles. The exterior of the dwelling is clad in vinyl siding. Windows are primarily one-over-one, vinyl-sash replacement units, flanked by inoperable, vinyl louvered shutters on the primary (southeast) elevation. The first floor of the primary elevation features a hipped-roof bay window with two support brackets in the southwest bay and a picture window located in the northeast bay. The central, primary entrance contains a modern wood door with an oval light, flanked by sidelights. A shed-roof, brick and concrete porch extends along the two northeast bays of the main block's primary elevation and is supported by square wood posts. A metal roll-top door with lights in the upper panel is centered on the attached garage's northeast elevation. The rear (northwest) elevation is not visible from the public right of way. The dwelling stands atop a parged foundation.

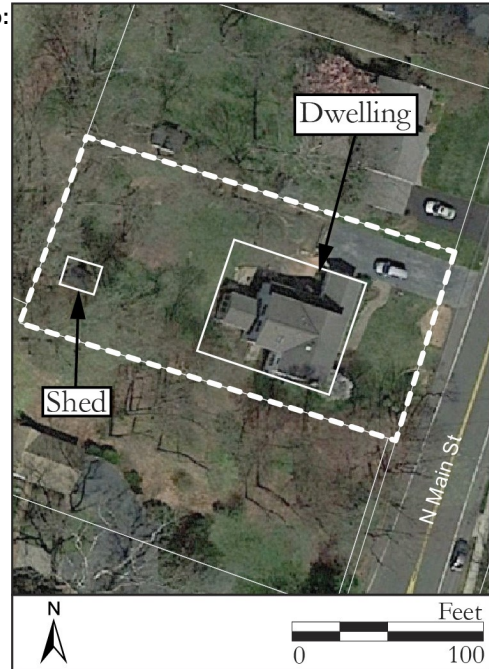
Site Map:

109 North Main Street is sited on a rectangular parcel (Block 25, Lot 29.02) located on the northwest side of North Main Street in Cranbury Township, Middlesex County, New Jersey. The dwelling is oriented with its primary elevation facing southeast and is set back approximately 50 feet from the road. An asphalt driveway extends along the northeast border of the property. A paved stone path extends from the driveway to the main entry. Mature trees and shrubs are planted within close proximity to the dwelling. The subject property is located in a residential neighborhood surrounded by properties dating from the mid-nineteenth to the late twentieth centuries.
