PROPERTY REPORT

Property Name: 16 Prospect Street **Ownership:** Private
Address: 16 Prospect ST **Apartment #:** **ZIP:** 08512

Survey Name: Cranbury Historic Sites Survey Phase III

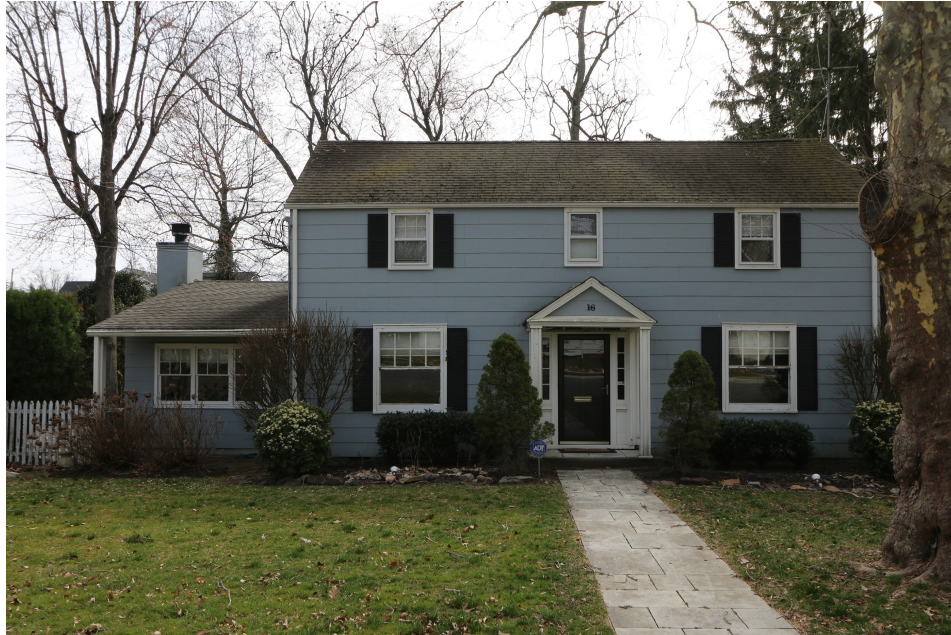
Property Photo:

16 Prospect Street is a two-story-tall, three-bay-wide, one-bay-deep, frame dwelling constructed circa 1880. The dwelling consists of a side-gabled main block with a one-story-tall, shed-roof addition to the northeast (added circa 1950) and a two-story, cross-gabled, rear (southeast) addition (added circa 1950, raised to two stories circa 2000), Asphalt shingles cover the roof throughout. The exterior of the dwelling is clad in machined shingles. An exterior, parged chimney is centered on the northeast elevation of the northeast wing. Windows are generally single and grouped, six-over-one, double-hung, wood-sash units, with some eight-over-one units on the first floor of the primary (northwest) elevation of the main block. The primary elevation of the main block has symmetrical fenestration with inoperable, louvered vinyl shutters flanking the windows in the outer bays. The central, primary entrance contains a paneled wood door with a glazed storm door, set within a wood surround with segmented sidelights. The entrance is sheltered by a pediment-front portico with square wood columns. The southwest and northeast elevations of the main block feature paired of six-over-one, wood-sash windows sashes in the gable ends, below the gable peak (historic, likely original). A deep overhang accents the northwest roof line on the northeast wing. The rear additions are largely obscured from the public-right-of-way. They appear to be clad in vinyl siding and contain asymmetrical fenestration with vinyl-sash windows and wall dormers.

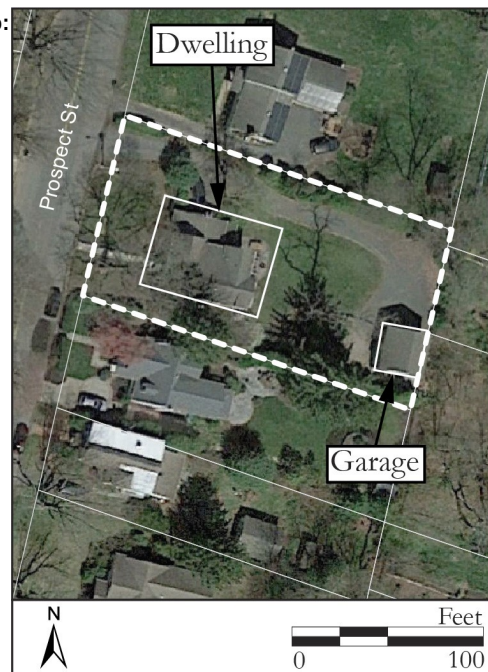
Site Map:

16 Prospect Street is sited on a rectangular-shaped parcel (Block 28, Lot 16) located on the southeast side Prospect Street in Cranbury Township, Middlesex County, New Jersey. The dwelling is oriented with its primary elevation facing northwest and is set back approximately 50 feet from the road. A gravel driveway extends along the northern and eastern borders of the property and connects to the detached garage. Mature trees and shrubs are planted within close proximity to the dwelling. The subject dwelling is located in a residential neighborhood surrounded by properties generally dating from the mid-nineteenth to the late twentieth centuries.
