New Jersey Department of Environmental Protection Historic Preservation Office

PROPERTY REPORT

Property Name:8 Prospect StreetOwnership:PrivateAddress:8 PROSPECT STApartment #:ZIP:08512

Survey Name: Cranbury Local Historic District Survey 2018

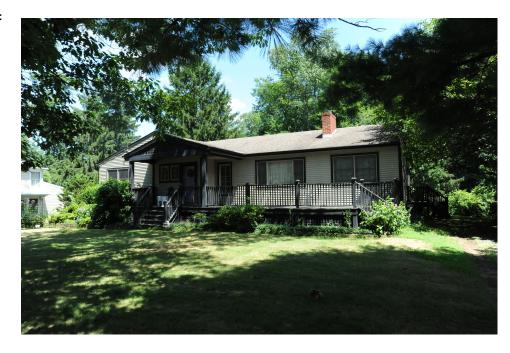
Property Photo:

PS&S recommends that 8 Prospect Street, constructed ca. 1961, is a non-contributing property in the Cranbury Historic District.

The 1-story, side gable-roofed, rectangular plan main block of this aluminum siding-clad, frame dwelling on a concrete foundation is 6 bays wide and 3 bays deep and is fronted on the northwest by a 1-story, 2-bay, gabled porch and backed by 2 1-story, gable-roofed volumes to the northeast and southwest. A 3-bay, gable-roofed projecting volume is located in northeast bays of the northwest elevation. The roofs are predominantly clad in asphalt shingle and the windows predominantly have 6/6 sash. An interior brick chimney is located towards the southwest of the northwest roof slope. The front porch, which is accessed by a straight wood stair, includes square-plan posts, a trellised gable-end, and a simple rail with square-plan balusters. The porch extends into an uncovered deck across the southwest bays of the northwest elevation. The primary entrance to the residence, located in the southwest bay of the projecting volume and is flanked by a double window. A double window lights the northeast bay. The main block is lighted by a fixed 10-light window to the northeast, a central multi-light picture window flanked by smaller 6/6 windows in the central bay, and a double window in the southwest bay. The southwest, side elevation, only partially visible from the public right-of-way, includes a secondary entrance accessed by a wood stair. The northeast, side elevation is regularly fenestrated. The southeast, rear elevation is not visible from the public right-of-way.
