PROPERTY REPORT

Property Name: Elwood Van Dusen House **Ownership:** Private
Address: 97 N Main ST **Apartment #:** **ZIP:** 08512

Survey Name: Cranbury CLG Survey 2017

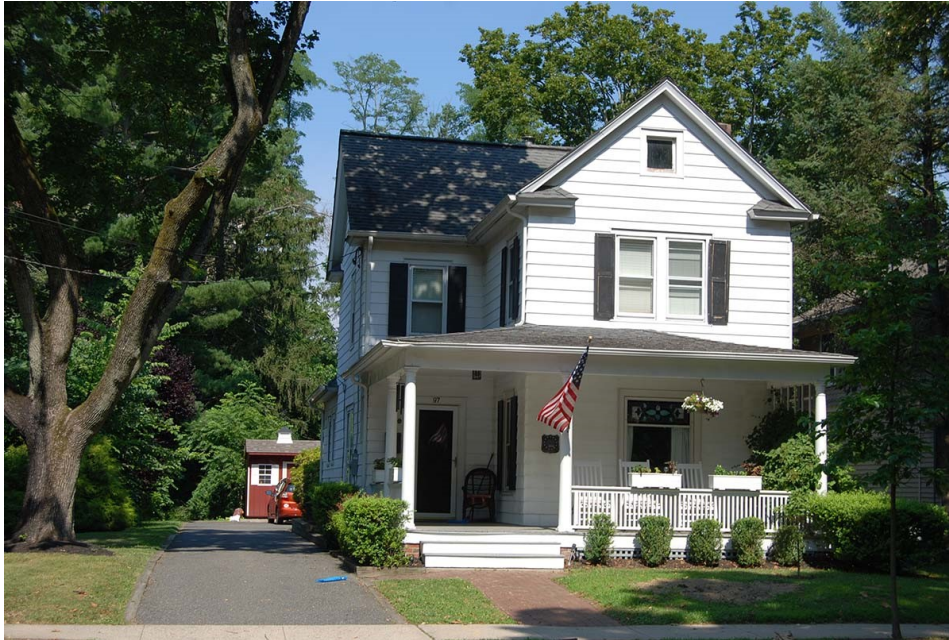
Property Photo:

The Elwood Van Dusen House at 97 North Main Street is a two-story tall, three-bay wide, three-bay deep, frame private residence constructed circa 1896 in a vernacular style. The dwelling has a front gable and wing form with a one-story addition to the rear. The house has a simple molded cornice and wood soffits. An exterior brick chimney is attached onto the north elevation, and an interior brick chimney is located near the west wall. The frame walls are clad with aluminum siding. Fenestration is primarily replacement one-over-one units with vinyl sashes, many with two-paneled shutters. On the main (east) elevation, the face of the front gable has a square attic window, a paired unit on the second floor, and a picture window on the first floor with an original stained glass transom. The house has an L-shaped front porch that wraps around the east and south sides of the front gable; its shallow-pitched hipped roof is clad with asphalt shingles and is supported by three thin, unfluted Doric columns connected by a railing of square balusters. The door is located at the rear of the porch and appears to be a replacement unit. The porch features brick piers below the columns and two frame steps leading down to the grade of the front lawn.

The north elevation is a mostly solid wall. The wall cladding is repeated from the main elevation: asphalt shingles on the roof and aluminum walls. The attached brick chimney is the key feature of the elevation. The south elevation faces onto the property drive. The exterior cladding of the house is again repeated: asphalt shingles on the roof and aluminum walls. Fenestration consists of one-over-one replacement vinyl sash units; those on the south elevation of the gable front have two-paneled shutters, and the first floor window on the

south gable is paired. The house has a stone foundation.

The rear addition is a two-story, gabled section that extends along the entire rear of the house core. Its roof is clad with asphalt shingles; the steep profile means that the view of the addition from the public right-of-way has the appearance of a one-story section. The addition has three small windows on the south elevation and a single window on the north elevation.

Character-defining elements of the dwelling include the original L-shape, the front porch, and the stained glass window.
