PROPERTY REPORT

Property Name: Robert McChesney House **Ownership:** Private
Address: 89 N Main ST **Apartment #:** **ZIP:** 08512

Survey Name: Cranbury CLG Survey 2017

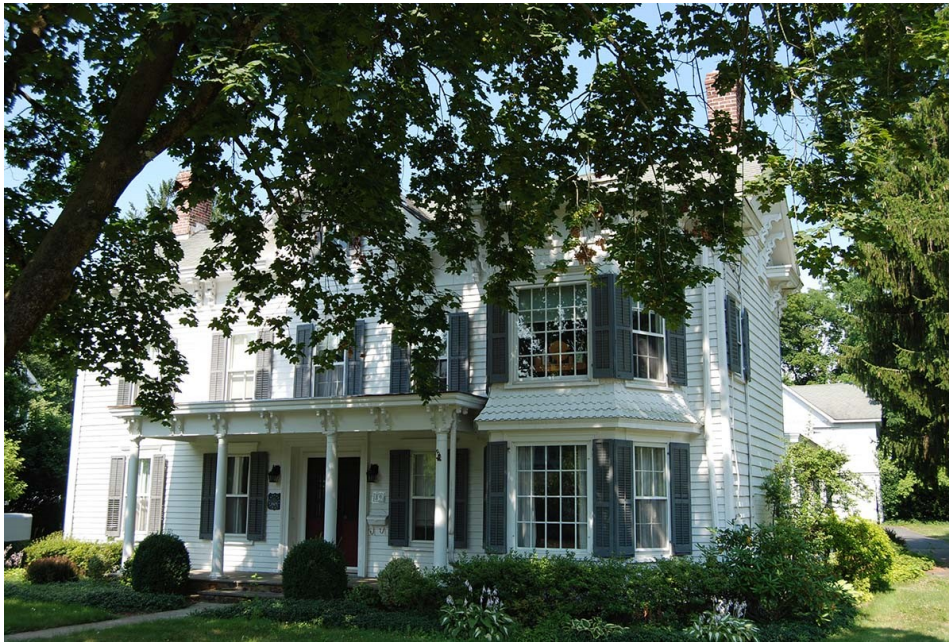
Property Photo:

The Robert McChesney House at 89 North Main Street is a two-and-a-half-story, five-bay, one-pile, frame private residence constructed circa 1825 and later renovated with Queen Anne style elements. The house has two rear additions: a two-story section aligned with the north end wall and a one-story section aligned with the south end wall.

The main block has a cross-gabled roof sheathed with asphalt shingles. A shallow centered cross-gable breaks through the molded cornice. A square brick interior chimney is located near each end of the ridge. The thick molded cornice doubles as an interior gutter system and is supported by thick brackets that are attached to an expressed wood frieze. The exterior of the dwelling is clad in wood clapboard siding. Fenestration is generally symmetrical. Windows on the main elevation include some two-over-two wood sash units (dating to the late nineteenth century) and some six-over-six wood-sash units (possibly original) with aluminum screen windows and molded wood lintels. Operable louvered shutters flank the windows. A rectangular bay aligned with the north wall is a two-story element. The bay has a shed roof, and the main block's molded cornice with its brackets and frieze wrap around the bay. The bay's second floor is clad with hexagonal wood shingles, and the first floor is clad with clapboards. The face of the bay has a large multi-light window on the first and second floor level, each with undersized louvered shutters, and the flanking panels have a six-over-six double hung sash window (possibly dating to the construction of the bay) flanked by louvered shutters. The central entrance consists of paired one-light, one-panel wood doors in a molded surround. The front porch is a one-story element extending over the center three bays. It has a hipped, nearly flat

roof with a bracketed cornice and wood frieze, supported by four Doric columns. The house has a stone foundation.
