## PROPERTY REPORT

**Property Name:** Robert McChesney House

**Address:** 89 N Main ST

**Survey Name:** Cranbury CLG Survey 2017

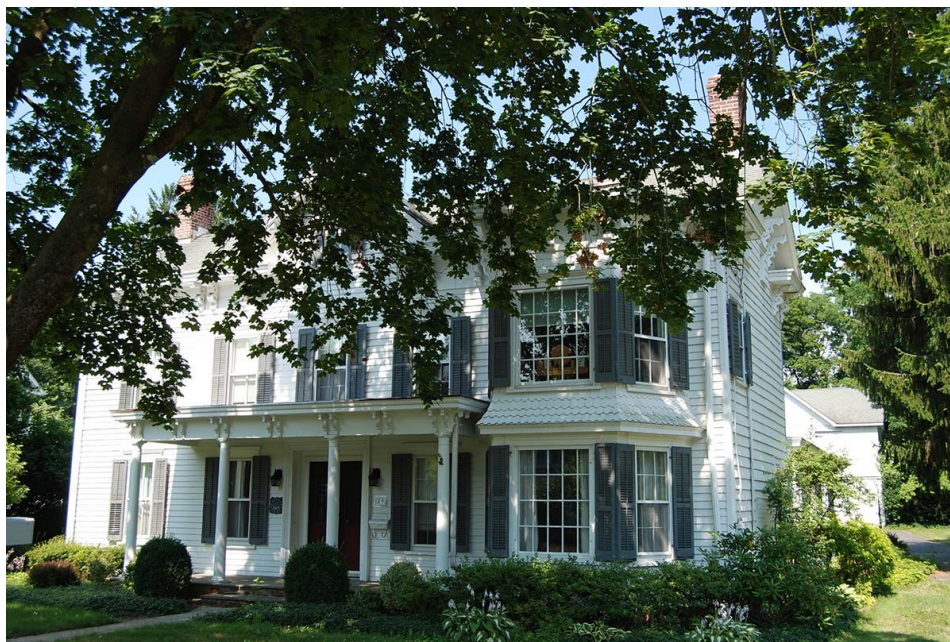
### Property Photo:

The Robert McChesney House at 89 North Main Street is a two-and-a-half-story, five-bay, one-pile, frame private residence constructed circa 1825 and later renovated with Queen Anne style elements. The house has two rear additions: a two-story section aligned with the north end wall and a one-story section aligned with the south end wall.

The main block has a cross-gabled roof sheathed with asphalt shingles. A shallow centered cross-gable breaks through the molded cornice. A square brick interior chimney is located near each end of the ridge. The thick molded cornice doubles as an interior gutter system and is supported by thick brackets that are attached to an expressed wood frieze. The exterior of the dwelling is clad in wood clapboard siding. Fenestration is generally symmetrical. Windows on the main elevation include some two-over-two wood sash units (dating to the late nineteenth century) and some six-over-six wood-sash units (possibly original) with aluminum screen windows and molded wood lintels. Operable louvered shutters flank the windows. A rectangular bay aligned with the north wall is a two-story element. The bay has a shed roof, and the main block's molded cornice with its brackets and frieze wrap around the bay. The bay's second floor is clad with hexagonal wood shingles, and the first floor is clad with clapboards. The face of the bay has a large multi-light window on the first and second floor level, each with undersized louvered shutters, and the flanking panels have a six-over-six double hung sash window (possibly dating to the construction of the bay) flanked by louvered shutters. The central entrance consists of paired one-light, one-panel wood doors in a molded surround. The front porch is a one-story element extending over the center three bays. It has a hipped, nearly flat

roof with a bracketed cornice and wood frieze, supported by four Doric columns. The house has a stone foundation.
