PROPERTY REPORT

Property Name: 88 North Main Street **Ownership:** Private
Address: 88 N Main ST **Apartment #:** **ZIP:** 08512

Survey Name: Cranbury CLG Survey 2017

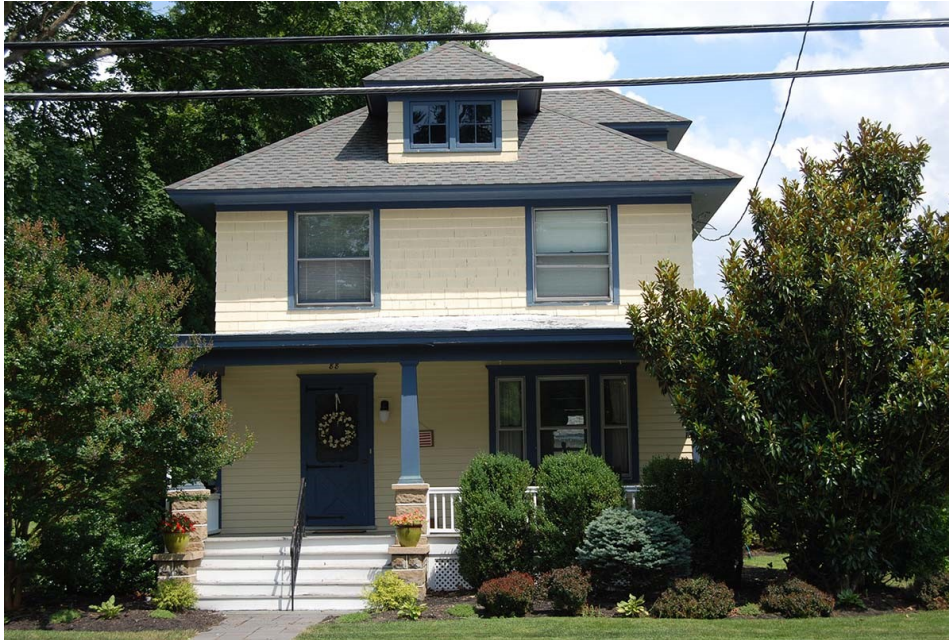
Property Photo:

88 North Main Street is a two-and-a-half-story, two-bay, two-pile, frame American Foursquare residence constructed circa 1920. The house has been enlarged with a one-story rear addition.

The main block of the house is a typical American Foursquare. Its deeply hipped (nearly pyramidal) roof is sheathed with asphalt shingles. Hipped roof dormers are located on the main (west) and south slopes of the roof; each has a paired four-light casement window (possibly original). The overhanging eaves are clad with wood siding. An exterior brick chimney stands on the north elevation near the northeast corner. The frame walls are clad with wood shingle siding. Fenestration consists primarily of one-over-one, double-hung, wood-sash windows (possibly original) with molded wood lintels and aluminum screen windows. The main elevation has two such windows on the second floor, aligned horizontally and vertically over the first floor wall openings. The entrance, located in the north bay, consists of a replacement door within a molded wood surround. South of the door is a tripartite one-over-one window (possibly original). The one-story front porch consists of a hipped roof supported by three thin tapered square columns standing on cast stone piers connected by a low railing with square balusters. The house has a concrete foundation.

The south elevation repeats many features of the main elevation. The asphalt shingled roof has a hipped roof dormer with a paired four-light casement window and widely overhanging eaves clad with wood siding. The frame walls are clad with wood shingle siding.

Fenestration is symmetrical, with two one-over-one double hung sash windows (possibly original) on each floor. Dense vegetation prevents a clear documentation of the north elevation.

The rear addition is a one-story, full-width addition. It has a hipped roof and frame walls clad with wood shingles. The north and south walls have a one-over-one window.

Character-defining elements of the dwelling include a one-story porch and hipped dormers.
