PROPERTY REPORT

Property Name: Ralph C. Stults House **Ownership:** Private
Address: 6 Westminster PL **Apartment #:** **ZIP:** 08512

Survey Name: Cranbury CLG Survey 2017

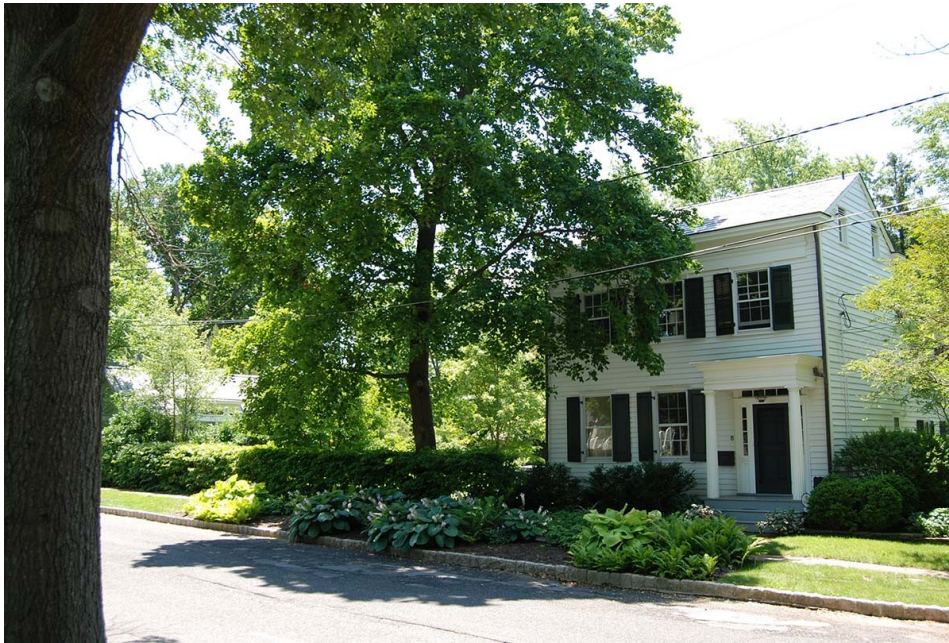
Property Photo:

The Ralph C. Stults House at 6 Westminister Place is a two-and-a-half story tall, three-bay wide, two-bay deep frame private residence constructed circa 1839 in a vernacular Greek Revival style. The dwelling, which sits on a masonry foundation, consists of a rectangular, side-gabled main block; a two-story, two-bay frame rear (southwest) ell (built circa 1870); a one-story, three-bay frame shed roof addition adjoining the ell to the northeast (built circa 1910); and a one-story, one-bay frame shed roof addition across rear of the dwelling (built circa 1910). The main block and the rear ell have asphalt shingle roofs, while the shed roof additions are capped by standing seam metal roofs. The main block and rear ell have a return cornice at the gable ends. Two brick, interior chimneys pierce the roof: one at the southeast gable end of the main block and one at the southwest gable end of the ell. The dwelling is clad in wood clapboard siding on all elevations. A molded wood frieze is featured prominently on the front elevation below a molded wood cornice. Windows on the front elevation are six-over-six, double-hung, potentially original wood-sash windows with louvered shutters on the second floor and paneled shutters on the first floor. The entrance, located in the west bay, is a six-panel wood door within a molded wood surround. Segmented sidelights above molded rectangular panels flank the entrance, which is topped by a segmented, rectangular transom. A one-story entry porch with fluted Doric columns shelters the entrance. The flat porch roof has a prominent molded wood cornice and dentil trim. Two four-light fixed wood windows (likely original) sit in the northwest gable end of the main block. A small, single six-over-six, double-hung wood wash window (likely original) on the first floor is the only opening on the northwest elevation of the main block. On the ell, six-over-six,

double-hung wood sash windows (likely original) with louvered shutters are spaced evenly across the façade. A secondary entrance, a wood door with a single pane of glass, provides access to the rear shed roof addition. This secondary entrance is sheltered by a one-story entry porch with fluted Doric columns and a flat roof with a molded wood cornice and wood frieze. The rear elevation is not visible from the public right-of-way. The northeast elevation features two four-light fixed wood windows (likely original) in the gable end and a six-over-six, double-hung wood-sash window (likely original) with louvered shutters on the first floor. The second floor of the ell has fixed wood windows (likely original) with three square lights. Windows on the first floor of the northeast shed roof addition are paired four-over-four replacement vinyl units; the adjoining window units give the appearance of an enclosed porch. Character-defining features of the dwelling include the wood frieze on the front elevation and six-over-six, double-hung wood-sash windows. A one-story frame garage, constructed circa 1900 during the district's period of significance, is located south of the dwelling. A one-story frame outbuilding, constructed circa 2010, is located east of the dwelling.
