PROPERTY REPORT

Property Name: George Barclay House

Address: 10 PARK PL E

Survey Name: Cranbury Local Historic District Survey 2018

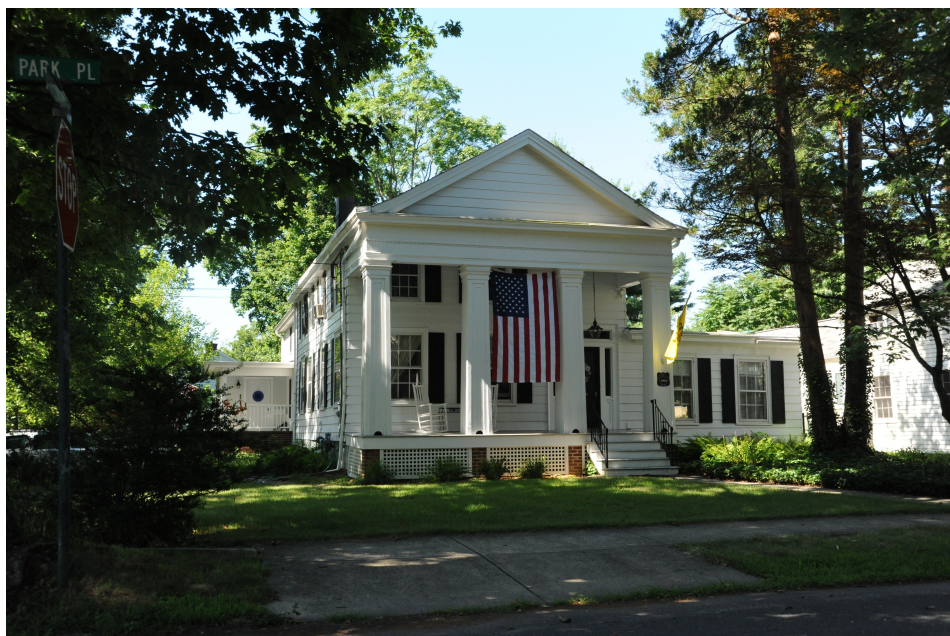
Property Photo:

PS&S recommends that 10 Park Place East, constructed circa 1840, is a contributing property in the Cranbury Historic District.

The 2-story, gable-roofed, rectangular-plan main block of this clapboard-clad, frame Greek Revival-style residence on a parged foundation is 3 bays wide and 4 bays deep and is fronted on the northeast by a full-height, full-width, pedimented porch and backed on the southwest by an addition consisting of a 2-story volume backed by a 1-story volume that wraps around its southeast side. A 1-story, historic full-depth side volume is located on the northwest of the historic main volume. An interior concrete block chimney is located on the southeast roof slope near the northeast bay. The roofs are predominantly clad in asphalt shingle and the windows predominantly have 6/6, double-hung, historic wood sash with applied shutters. The pedimented front porch, which is accessed by a straight wood stair with wrought iron rail in the northwest bay, includes 4 substantial, square-plan pillars with full-height recessed panels and half-round cutouts at the base. The entablature of the pediment includes a frieze with an upper course of small dentils and an unornamented, wide cornice. The primary entrance to the residence, located in the northwest bay of the northeast elevation, includes a historic paneled door and a historic door surround with single-light sidelights over recessed panels and a single-light transom. The 2 southeast bays of the main block and the 1-story side volume are regularly fenestrated. The southeast, side elevation of the main block is regularly fenestrated, though the window sash varies in the rear bays. The added volume is regularly fenestrated and includes an entry porch with a brick cheek wall and a simple post and rail. An entrance to the rear volume is located on the northeast elevation of the 1-story volume. The northwest, side and

southwest, rear elevations are not visible from the public right-of-way.

This property is a contributing property in the historic district because it retains integrity and historic, character-defining features as its historic temple-front porch, side volume, historic windows and wood cladding, and fenestration patterns.
