New Jersey Department of Environmental Protection Historic Preservation Office

PROPER	TY REPORT		Property ID	-566727815
Property Name:	Odd Fellows Hall		Owne	rship: Private
Address:	30 N Main ST	Ар	artment #:	ZIP: 08512
PROPERTY LOCATION(S):				
County:	Municipality:	Local Place Name: U	ISGS Quad: Block:	Lot:

Survey Name: Cranbury CLG Survey 2017 Surveyor: Kristen Herrick Organization: RGA, Inc.

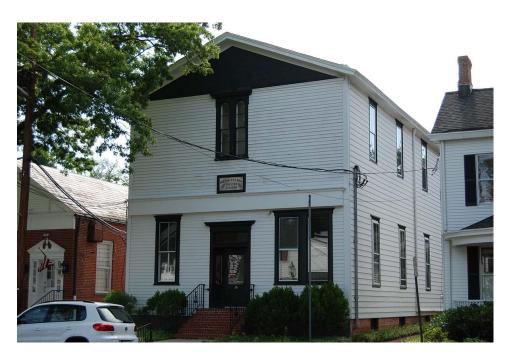
Property Photo:

Odd Fellows Hall at 30 North Main Street is a two-story-tall, three-bay wide, four-bay deep, frame fraternal building constructed in 1889. The building, which sits on a brick foundation, consists of a rectangular front-gabled main block; a one-story, two-bay addition; and a onestory, one-bay shed roof addition on the rear. The roof is sheathed with asphalt shingles. The exterior of the building is clad in wood clapboard siding on the front elevation and aluminum siding on the side elevations. The front gable end is clad in wood shingles. Paired two-over-two, double-hung, arched wood-sash windows (likely original) with a molded wood lintel sit in the center bay on the second floor. Below the window is a carved datestone that reads "Odd Fellows Hall, erected A.D. 1889." A wood frieze runs above the first floor of the building. Windows on the first floor are a four-over-four, double-hung wood-sash window within a molded surround (likely original) in the north bay and paired one-over-one, double-hung, vinyl-sash replacement windows within a molded surround in the south bay. The central entrance is a single-leaf door with a single pane above a molded panel. The door is flanked by canted sidelights with molded panels and topped by a rectangular transom within a molded wood surround. A brick stoop with six steps and wrought iron railings provides access to the entrance. Windows on the northwest elevation are two-over-two, double-hung, wood-sash (likely original). The rear elevation is not visible from the public right-of-way. Windows on the southeast elevation are also two-over-two, double-hung, wood-sash (likely original).

The 1989 Heritage Studies survey identified Odd Fellows Hall at 30 North Main Street as a contributing resource to the Cranbury Historic District. RGA concurs with the previous evaluation and recommends Odd Fellows Hall at 30 North Main Street as a contributing resource due to its date of construction, design, and use of materials compatible with the district.

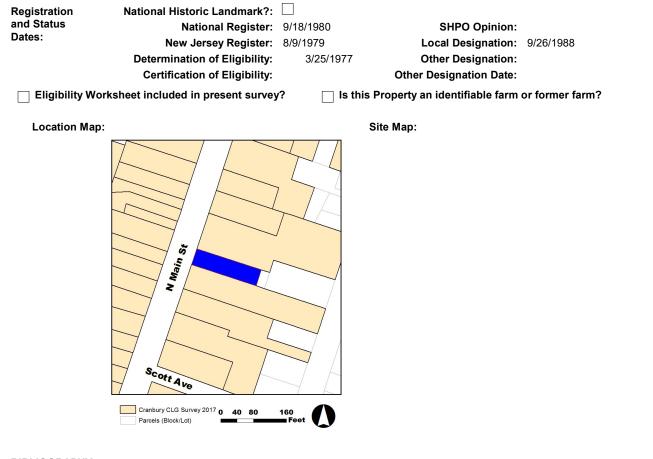
Odd Fellows Hall is sited on a rectangular parcel (Block 32, Lot 8) located on the west side of North Main Street in Cranbury Township, Middlesex County, New Jersey. The building is oriented with its primary elevation facing northwest and is set back approximately 15 feet from North Main Street. A concrete sidewalk, which runs along North Main Street, spans the west side of the parcel. A paved driveway leads east from North Main Street past the northeast elevation of the building to a paved parking lot and a one-story garage. Shrubs adjoin the front (northwest) elevation. Odd Fellows Hall is located in a mixed residential and commercial neighborhood surrounded by properties dating from the mid-nineteenth to the early twentieth century.
