PROPERTY REPORT

Property Name: John Embley House
Address: 10 N Main ST

Survey Name: Cranbury CLG Survey 2017

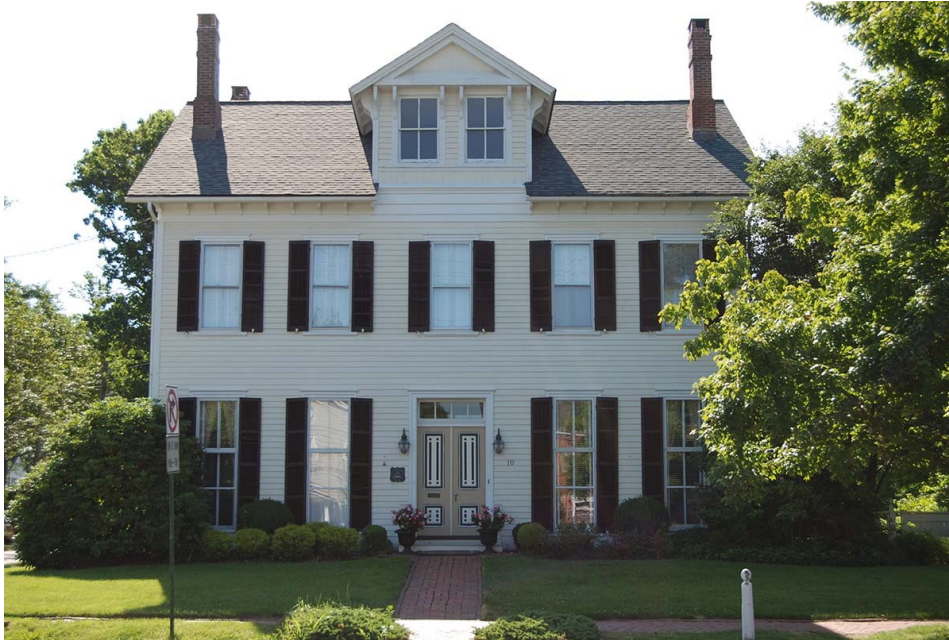
Property Photo:

The John Embley House at 10 North Main Street is a two-and-a-half-story tall, five-bay wide, three-bay deep, frame private residence constructed circa 1881 in a vernacular style. The dwelling, which sits on a brick foundation, consists of a rectangular, side-gabled main block; a two-story, two-bay addition and a one-story, one-bay shed roof addition to the southeast (built circa 1900); and a one-story, one-bay, hipped roof addition to the northeast (built circa 1900). The roof, which has overhanging eaves supported by brackets, is sheathed with asphalt shingles. Interior corbelled brick chimneys pierce the roof: two on the northwest bent and two on the southeast bent, all at the gable ends. An interior brick chimney is located on the one-story hipped roof addition. A large central front-gabled dormer rests on the northwest and southeast bents of the roof. Each dormer has overhanging eaves supported by brackets at the corners and two two-over-two, double-hung, wood-sash windows (likely original). The exterior of the dwelling is clad in wood clapboard siding on the front (northwest) elevation and vinyl siding on the side and rear elevations. Regular fenestration on the front elevation consists of two-over-two, double-hung, wood-sash windows (likely original) with molded surrounds on the second floor and two-over-two triple-sash wood windows (likely original) on the first floor. Windows on the front elevation have louvered shutters. The central historic entrance consists of paired wood doors (original) with rectangular panels above square panels and a brass knob. The doors are set within a molded wood surround and topped by a rectangular, segmented transom. A one-step wood stoop provides access to the entrance. The northeast elevation features two two-over-two, double-hung, wood-sash windows (likely original) in the gable end. Windows on the first and second floors of the main block and additions are two-over-two, double-hung, wood-sash windows (likely original). The one-story shed roof addition features a six-

over-six vinyl-sash replacement window. All windows on the northeast elevation have louvered shutters. The southeast elevation features two two-over-two, double-hung, wood-sash windows (likely original) in the gable end. A two-story, semi-hexagonal projecting bay is located in the west bay of the main block. Windows on the first and second floors of the main block, the projecting bay, and two-story addition are two-over-two, double-hung, wood-sash (likely original). Only the windows on the main block have louvered shutters. The one-story shed roof addition has a six-over-one vinyl-sash replacement window. Character-defining elements of the dwelling include overhanging eaves supported by brackets, wood-sash windows, and two front-gabled dormers. A two-story, front-gabled frame carriage house, constructed circa 1881 during the district's period of significance and currently used as a garage, stands east of the dwelling.
