## PROPERTY REPORT

**Property Name:** John Embley House **Ownership:** Private  
**Address:** 10 N Main ST **Apartment #:** **ZIP:** 08512

**Survey Name:** Cranbury CLG Survey 2017

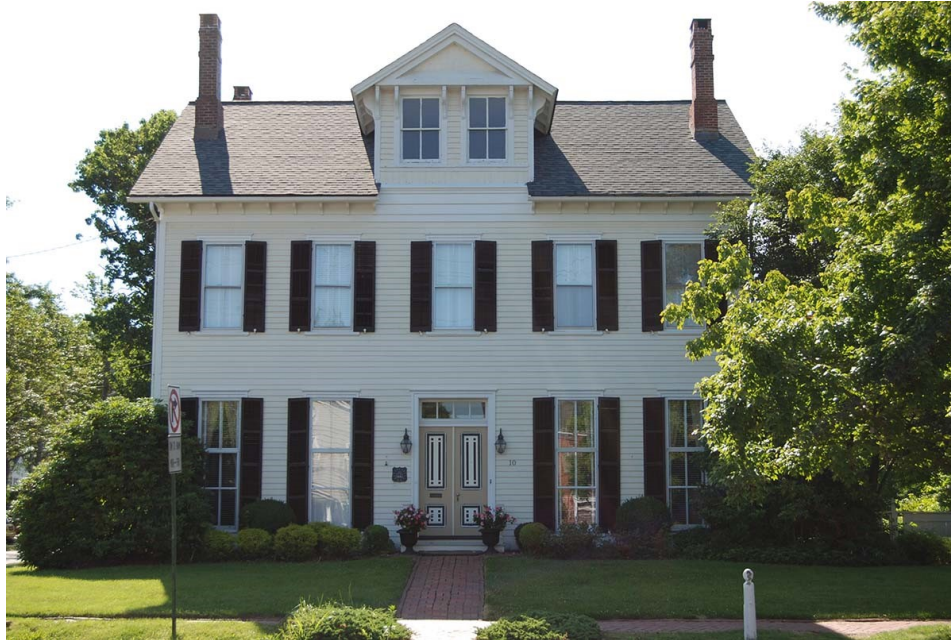
### Property Photo:

The John Embley House at 10 North Main Street is a two-and-a-half-story tall, five-bay wide, three-bay deep, frame private residence constructed circa 1881 in a vernacular style. The dwelling, which sits on a brick foundation, consists of a rectangular, side-gabled main block; a two-story, two-bay addition and a one-story, one-bay shed roof addition to the southeast (built circa 1900); and a one-story, one-bay, hipped roof addition to the northeast (built circa 1900). The roof, which has overhanging eaves supported by brackets, is sheathed with asphalt shingles. Interior corbelled brick chimneys pierce the roof: two on the northwest bent and two on the southeast bent, all at the gable ends. An interior brick chimney is located on the one-story hipped roof addition. A large central front-gabled dormer rests on the northwest and southeast bents of the roof. Each dormer has overhanging eaves supported by brackets at the corners and two two-over-two, double-hung, wood-sash windows (likely original). The exterior of the dwelling is clad in wood clapboard siding on the front (northwest) elevation and vinyl siding on the side and rear elevations. Regular fenestration on the front elevation consists of two-over-two, double-hung, wood-sash windows (likely original) with molded surrounds on the second floor and two-over-two triple-sash wood windows (likely original) on the first floor. Windows on the front elevation have louvered shutters. The central historic entrance consists of paired wood doors (original) with rectangular panels above square panels and a brass knob. The doors are set within a molded wood surround and topped by a rectangular, segmented transom. A one-step wood stoop provides access to the entrance. The northeast elevation features two two-over-two, double-hung, wood-sash windows (likely original) in the gable end. Windows on the first and second floors of the main block and additions are two-over-two, double-hung, wood-sash windows (likely original). The one-story shed roof addition features a six-
