## PROPERTY REPORT

**Property Name:** 2 Evans Drive  
**Address:** 2 EVANS DR  
**Ownership:** Private  
**Apartment #:**  
**ZIP:** 08512

**Survey Name:** Cranbury Local Historic District Survey 2018

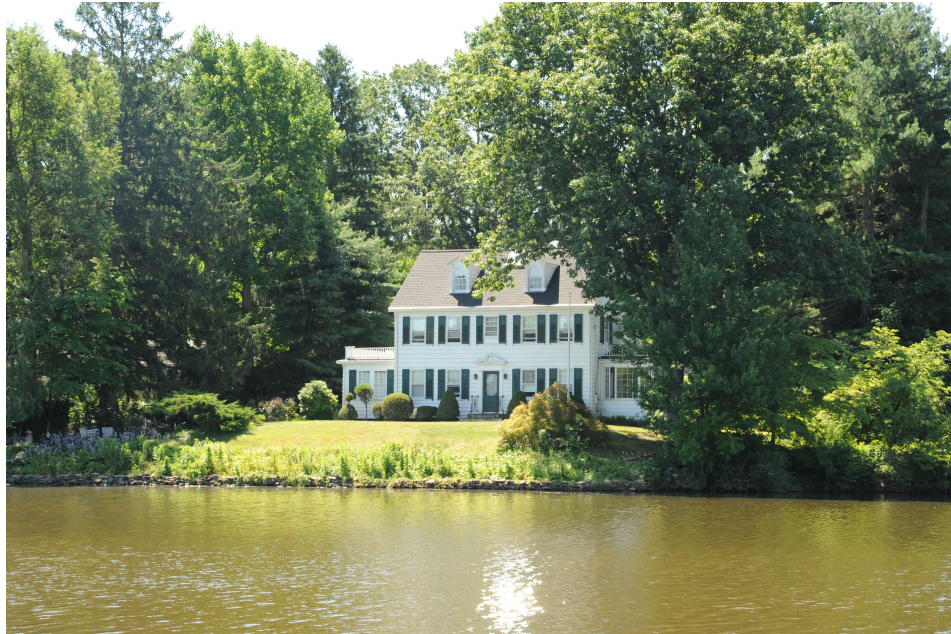
### Property Photo:

The 2 1/2-story, side gable-roofed, rectangular-plan main block of this painted wood clapboard-clad, Colonial Revival style frame dwelling on a parged foundation is 5-bays wide and 2 bays deep and is flanked by 1-story, hipped-roofed volumes with roofline railings on both its east and west. 2 gabled dormers with round-arch, multi-light sash windows are located on the north roof slope. Smaller, shed-roofed dormers with single-light windows are located on the south roof slope. The roofs are predominantly clad in asphalt shingle and the windows predominantly have 6/1, historic wood sash with historic shutters composed of a louvered lower panel and a solid upper panel with decorative, crescent-shape cutouts. A broad exterior, painted brick chimney centered on the west elevation. The primary entrance fronted by a concrete landing with historic, wrought iron railings, is centered on the north, water-facing elevation, and includes a historic screen door, a historic single-light door, and a historic door surround with a dentiled broken pediment with a central urn. The remaining bays are regularly fenestrated. The east side volume is lighted by a double window. The west side volume is lighted by a 20-light fixed window flanked by 10-light casement windows. The west elevation, only partially visible from the public right-of-way, is lighted by 2 windows on the second floor and 2 multi-light, quarter-round windows on the third floor. The east elevation is lighted by 2 windows on the second floor and a multi-light round window on the third floor. The south, street-facing elevation is only partially visible from the public right-of-way and includes a 9-light door with single-light transom and flanking 4/1 sash windows in the east volume.

This property is a contributing property in the historic district because it retains integrity and historic, character-defining features such as its historic massing and fenestration patterns, historic wood windows and shutters, historic clapboard, historic wood doors, historic dormers and side porches, historic wrought iron entrance railings, and its historic chimney.
