PROPERTY REPORT

Property Name: 52 South Main Street
Address: 52 S MAIN ST

PS&S recommends that 52 Main Street, which includes a residence and garage constructed circa 1920, is a contributing property in the Cranbury Historic District.

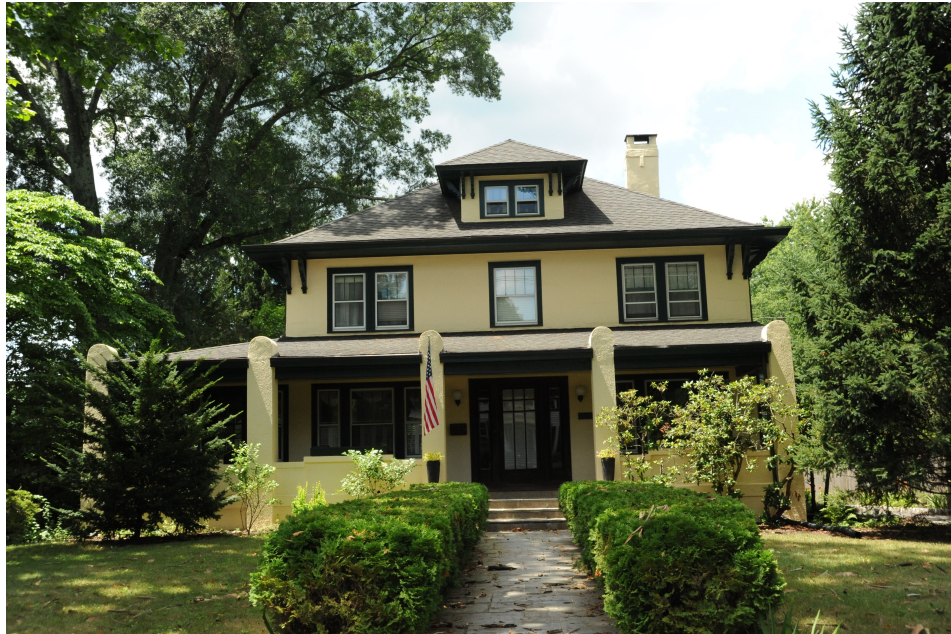
Property Photo:

The 2 1/2-story, hip-roofed, foursquare main block of this stuccoed, Craftsman-style dwelling on a stucco foundation is 3 bays wide and 2 bays deep and is fronted on the southeast by a hip-roofed, full-width porch that extends to the southwest to front a 1-story, hip-roofed, partial-width side volume, and backed on the northwest by a 1-story rear el offset to the northeast. A 1-story, hip-roofed, 3-sided bay projects from the southeast bay of the northeast elevation. A hip-roofed dormer projects from the southeast roof slope. An interior, stuccoed chimney is located near the center of the northeast, main roof slope. The roofs throughout are clad in asphalt shingle and have paired, shaped eave brackets along the cornice of the main block and the front dormer. The windows predominantly have 3/1 and 4/1 historic wood sash. The front porch, accessed by a stair in the central bay, includes a stuccoed knee wall with a raised central panel in each bay and stuccoed pillars with round-arched caps that project beyond the roofline. The primary, centered entrance includes a historic door with 6 small lights over 3 extended single lights and historic sidelights with 2 lights over 1 extended light. Both of the outer bays are lighted by a single 4/1 window flanked on either side by 2/1 windows. The second floor is lighted by a single 4/1 window in the central bay and paired 3/1 windows in the outer bays. A paired, smaller 3/1 window lights the dormer. The northeast, side elevation is regularly fenestrated and includes a triple window in the northwest bay of the first floor and a single window lighting the el. The southwest, side

elevation, only partially visible from the public right-of-way, is regularly fenestrated. The northwest, rear elevation is not visible from the public right-of-way. The 2 bay, side gable-roofed garage, located to the northwest of the residence, includes historic paired 3-light doors.

The residence at 52 S. Main Street contributes to the Cranbury Historic District because it retains integrity and historic, character-defining features such as its historic massing, historic windows, historic door and door surround, historic porch pillars and knee walls, historic eave brackets, historic chimney, and historic surface cladding. The matching garage it retains its historic doors.
